Microbiological Induced Corrosion in Stainless Steel Piping: Mitigation Strategy

Taner Serter

Asset Integrity Division, SADARA Chemical Co.

April 26th, 2017

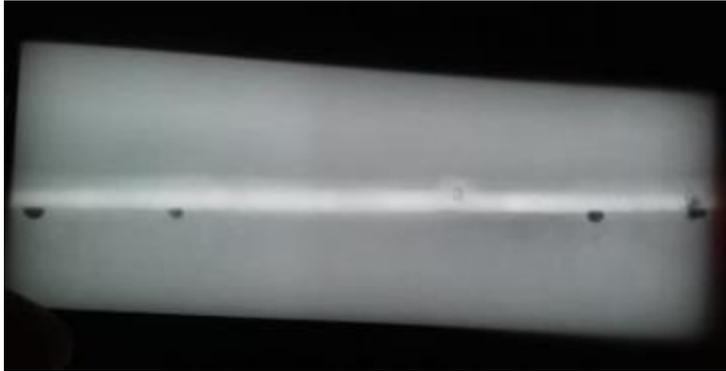
Sample Inspection Findings

- Defect Definition: Localized Pitting
- Defect Location: Pipe to Pipe/Pipe to Elbow/ HAZ and Weld
- Material Definition: A312 TP 304/304L- Sch10S
- Diameter Range: 4-30 inch(Higher the diameter more susceptible)

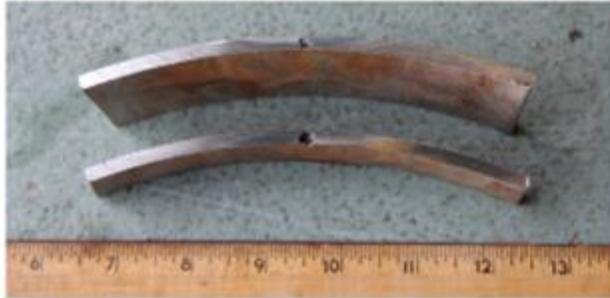
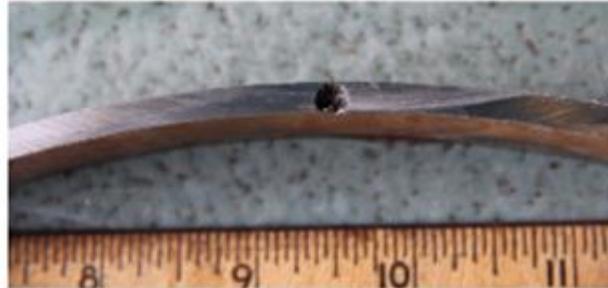
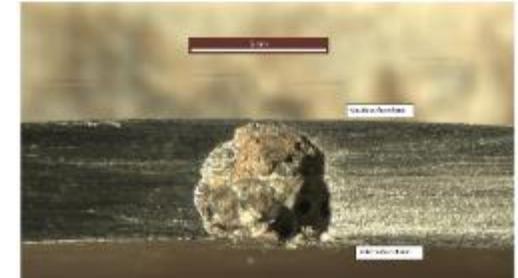
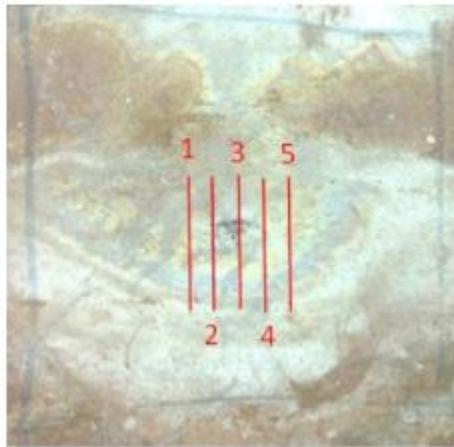
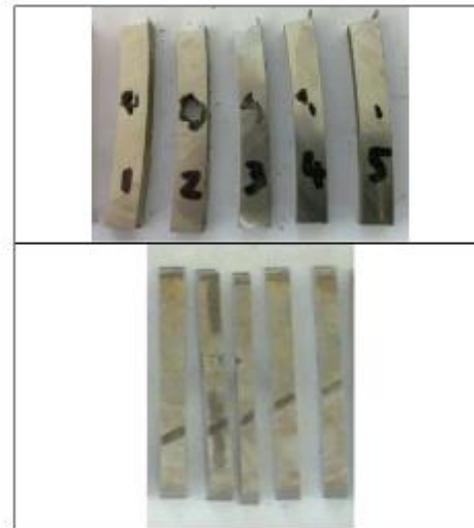
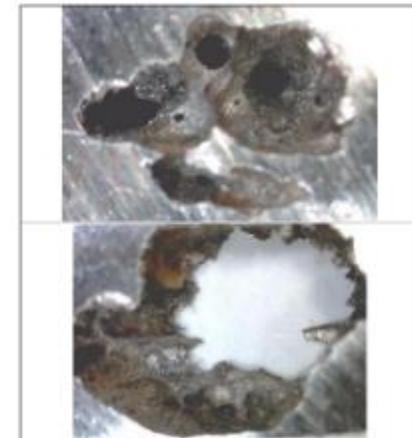
MIC Samples

Source:
Failure analysis reports by ARAMCO and AMCO

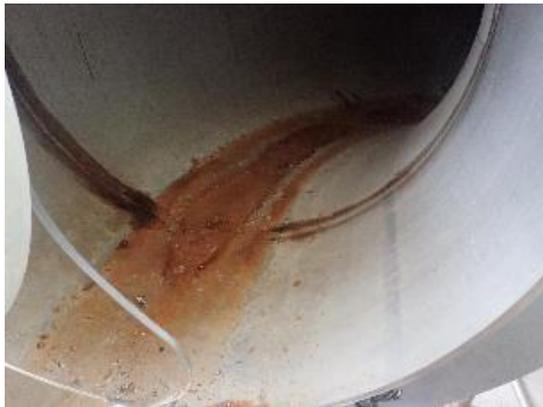
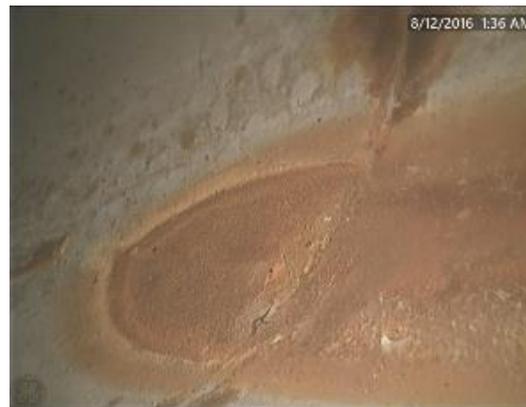
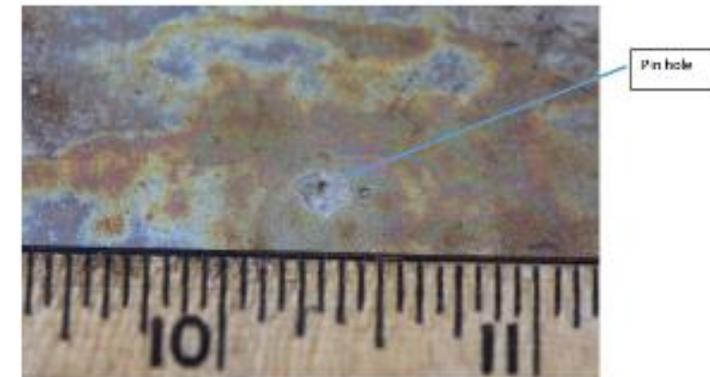
Causes were found:

- Improper Storage
- Design
- Inadequate flushing, draining and drying
- Improper preservation
- Non compliance with hydrostatic testing procedure

- Amended existing Hydrostatic Testing and Lay-Up procedure for emphasizing more stringent testing and control requirements
- Carried out extensive VT and RT inspections to investigate the extent of potential MIC locations
- Conducted inspection assessments for SS piping for remaining facilities under construction to validate system integrity
