SIDE WALL TUBE FAILURE IN LOW PRESSURE BOILER

Avtandil Khalil Bairamov, Saud Ghunaim Al-Subai
SABIC ATC, AI Corrosion Control Section

April 26-27, 2017

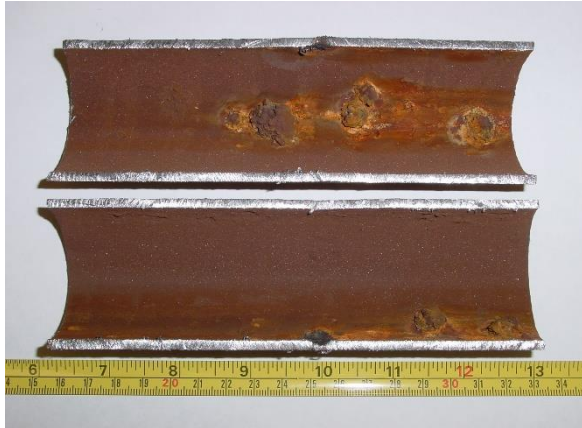
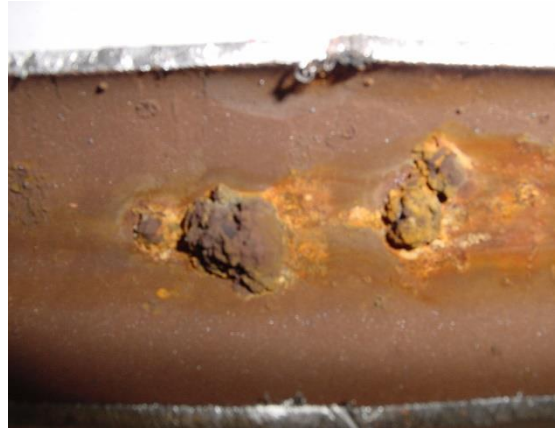
Figure 1: Close-up photos of split tube showing separate big (10 mm in height & diameters up to 12 mm) tubercles developed on ID surface exposed to hot gas.

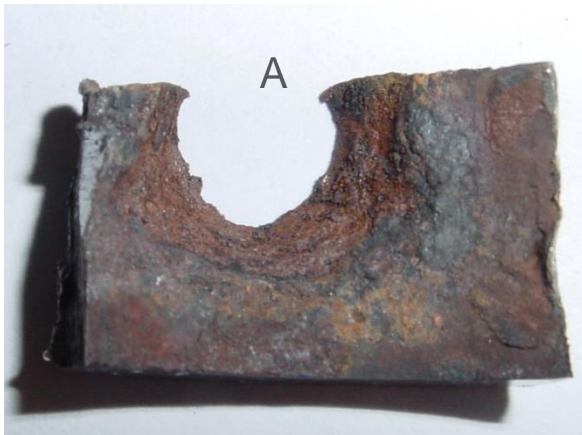
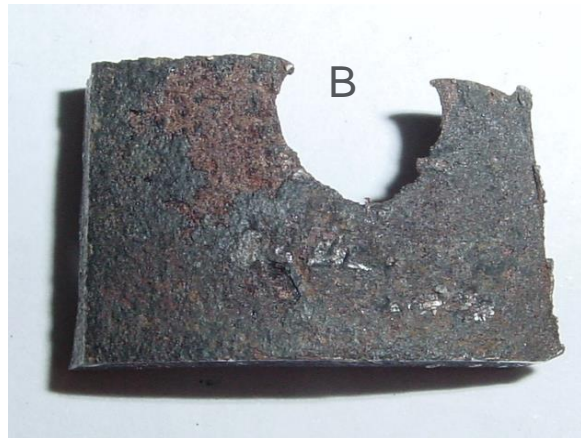
Figure 2: Photographs showing through thickness hole on ID (A) and OD (B) after mechanical removal of hard tubercle. Note conical crater of hole on ID.

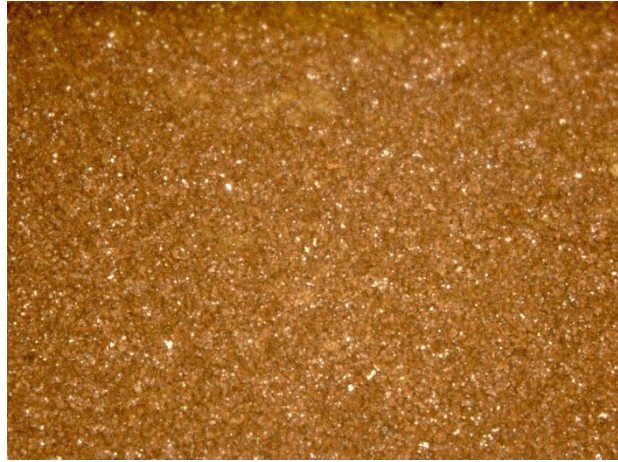
Figure 3: ID sound surface showing the presence of uniform brownish layer with incorporated numerous bright particles.

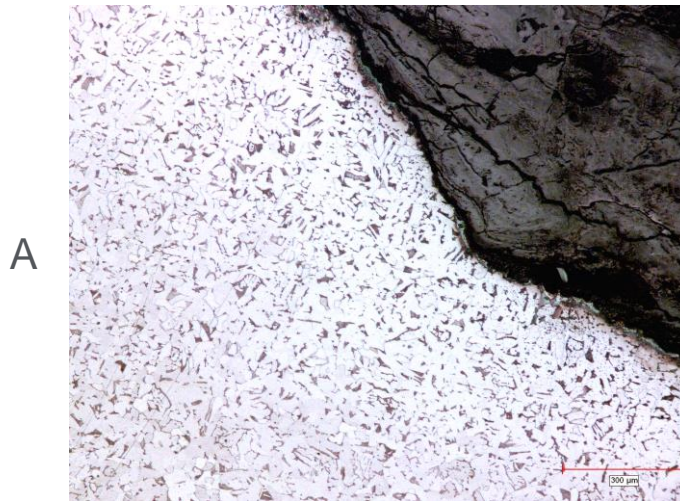
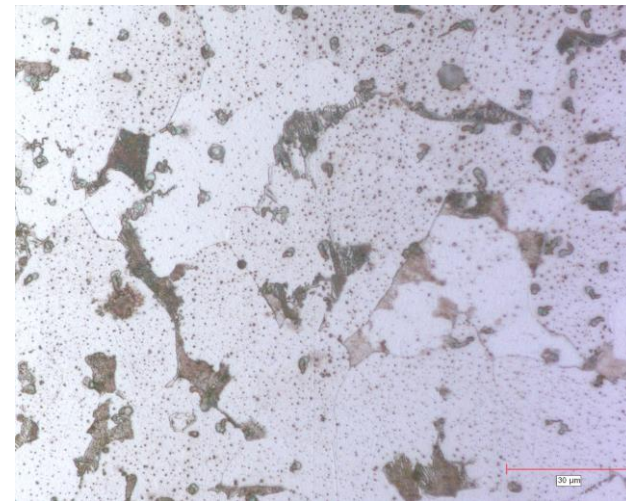
Figure 4: Normal pearlite-ferrite microstructure of area next to the hole at OD, A, 100X; B, 1000X.

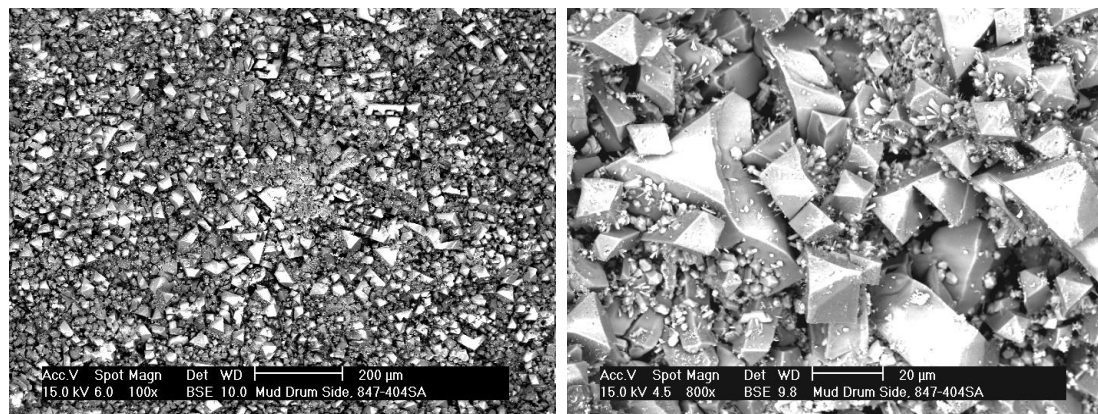
Figure 5: BSE images of ID sound surface showing numerous big pyramidal crystals along with finer particles and EDX spectra detecting high O, Mg, P, Ca and Cu peaks , (A, 100X; B, 800X).

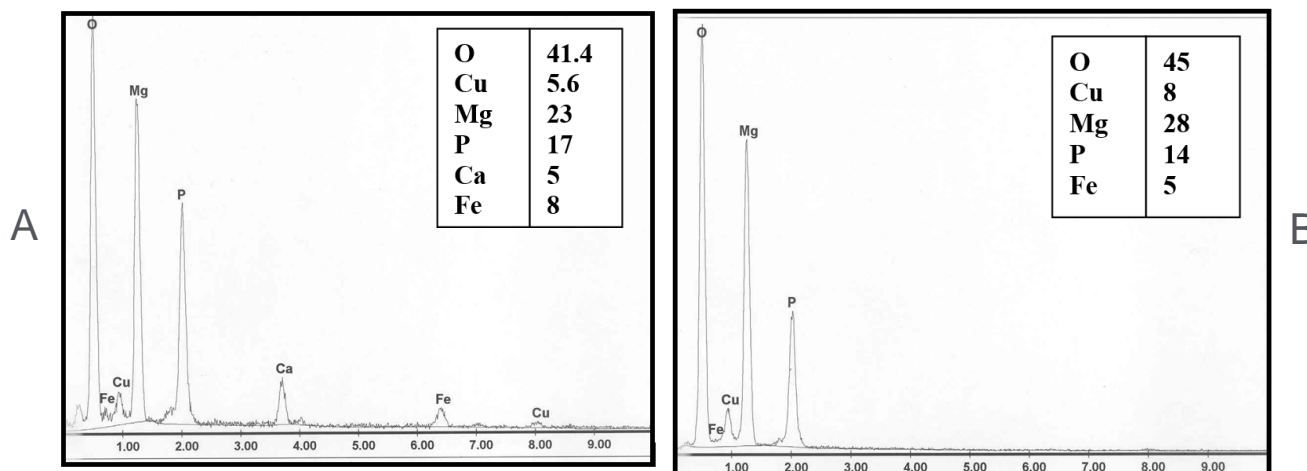
Figure 6: EDX spectra of the sound surfaces showed in Figure 5 (A – Area analysis ; (B) pyramidal crystals

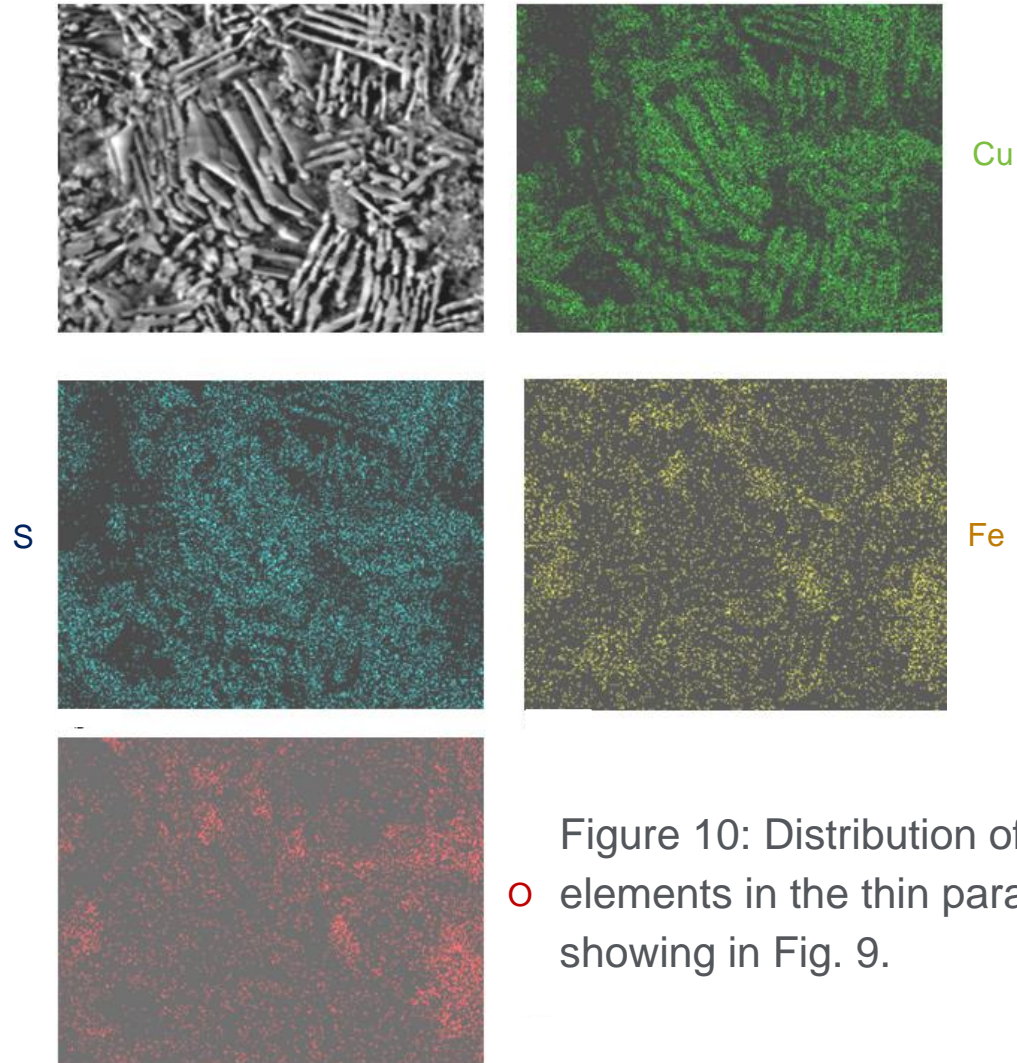
Figure 10: Distribution of the detected
○ elements in the thin parallel plate-like crystals showing in Fig. 9.

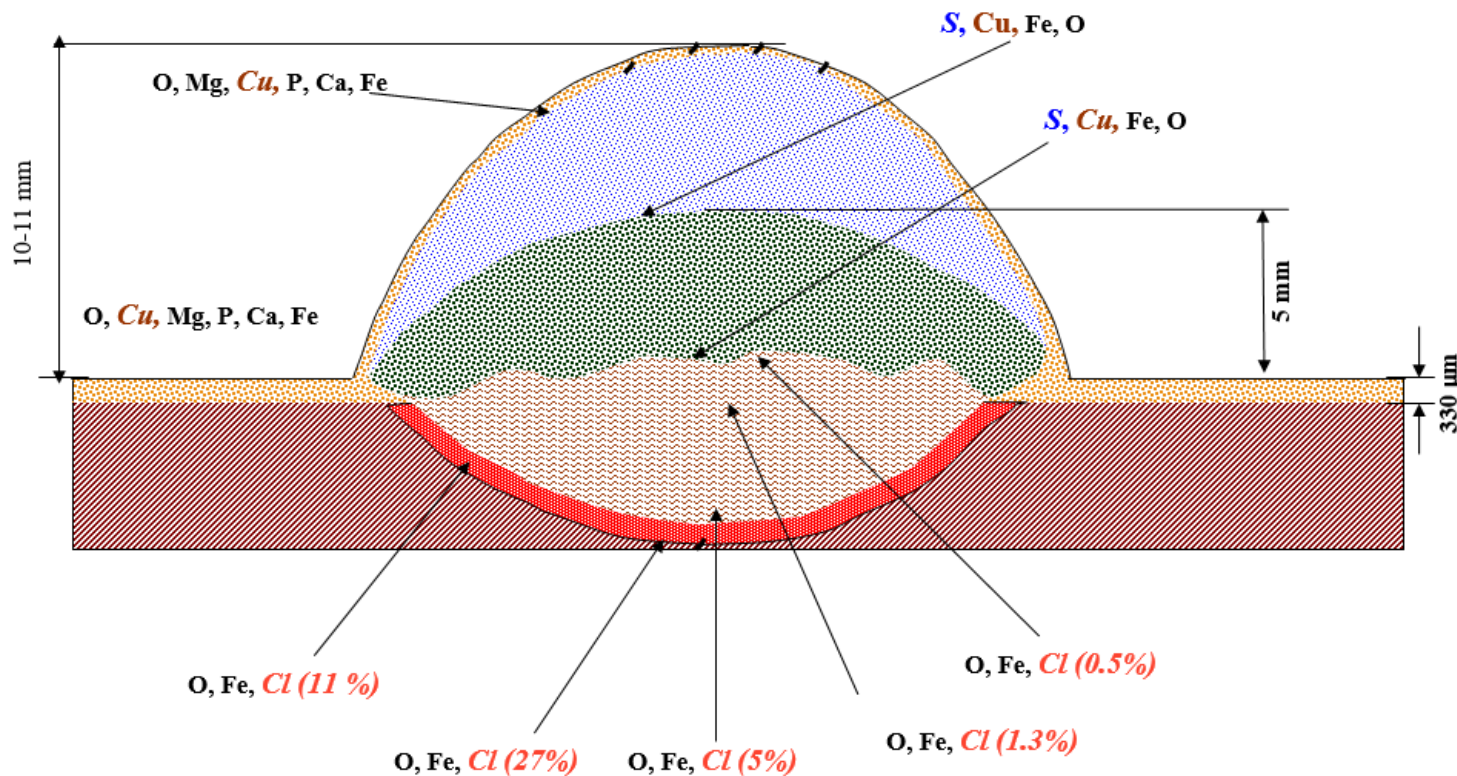
Figure 11: Schematic structure of the well-developed tubercle on the failed tube ID and distribution of the detected elements across thickness. Note high chlorine content in the bottom layers.

- No microstructural abnormalities.
- Highly structured tubercles with extremely high chlorides content in thin layer adjacent to the pit floor.
- Chlorides concentration gradually decreased from floor of the pit towards tubercle middle and was not found in areas above.
- Sea water mixed with BFW due to Cu-Ni tubes perforation in evaporation system resulting in increase of Cl and Cu contents and conductivity.
- Copper found mainly as elemental/metallic form with small quantity as copper sulfide.
- Maximum concentration of Cu was within thin (17 μ) layer about 70 μ away from tube metal surface in sound area.
- Copper was detected only on tubercle top portion, not in portion locate inside the hole.
- Generally, copper induced failures of boiler components are very rear in practice, excluding specific cases such as LME at welding.

- The results of failure investigation make it possible to conclude that the boiler tube failed according to chloride induced localized corrosion mechanism.
- Primary reason for such failure was mixing of sea water with BFW due to perforation of cupro-nickel tubes in the evaporating system.
- Presence of copper aggravated intensity of localized corrosion.
- Frequent shutdowns and start-ups with relatively long intervals promoted possible oxygen and MIC type of damages in some extend.
- Schematic structure of well-developed tubercle was proposed.

- Avoid any mixing of sea water with BFW
- Chemical cleaning was recommended followed with hydro test and plugging of leaked tubes.
- Actual remaining thickness should be determined.
- Both steam and mud drums should be inspected for any corrosion intensity
- Asses complete re-tubing, if practical.
- Elbow portions with weld joints of economizer inspected by radiography to asses integrity.
- Care should be given to more precise and frequent monitoring of chlorides, copper and oxygen contents in BFW.
- More steady operation of the boiler was also recommended.
