ANODE PERFORMANCE IN SERVICE CASE STUDIES

P.A. Noyce¹, P.A.J. Gibbs²

¹Electro Tech CP LLC, New York, USA, ²Electro Tech CP Ltd, Dubai, UAE

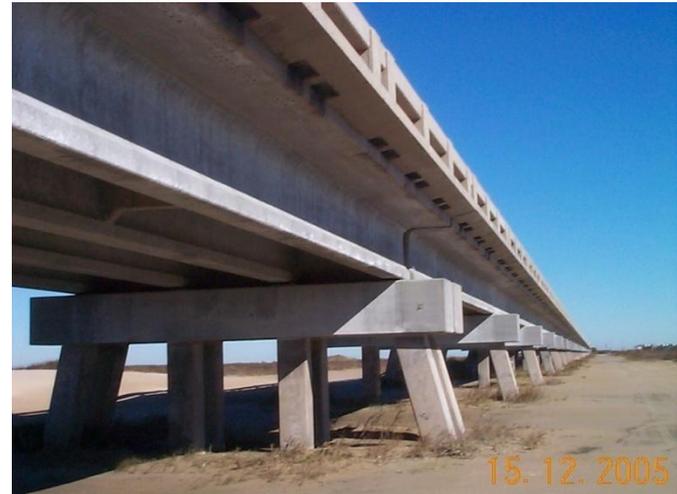
San Luis Pass Galveston Texas USA

- Completed in August 2003
- 320,000 Sq/ft
- 470 No. Pre-Stressed Beams
- 171 No. Pier Caps

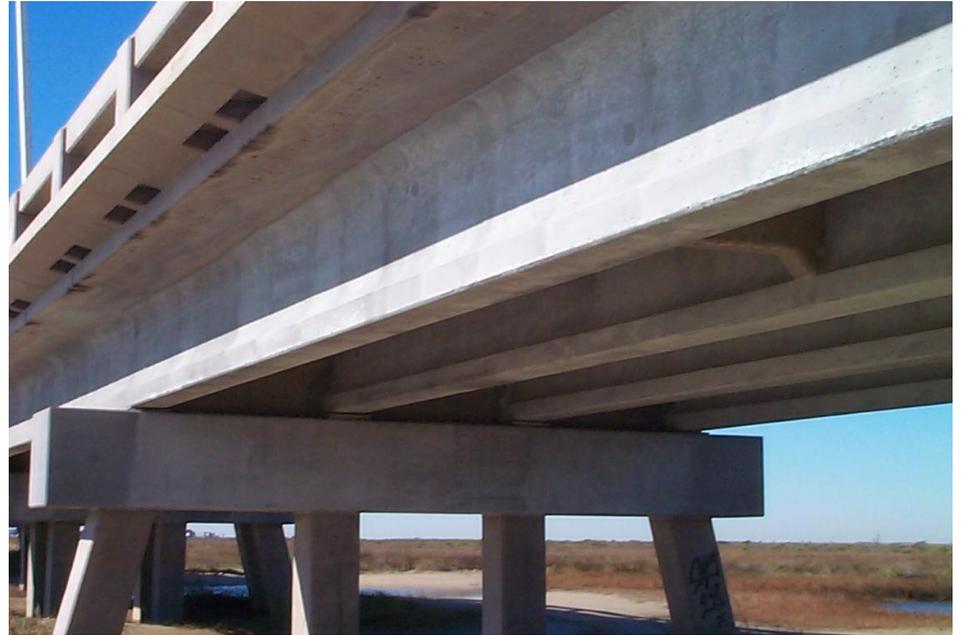
San Luis Pass Galveston Texas USA

Zinc Aluminium Indium Coating

- Initial Current Density
4.4mA/m² to 6.9mA/m²
- 7 Year Current Density
0.49mA/m² to 1.27mA/m².
- Minor Defects
- CP Not Compromised
- No Corrosion Found

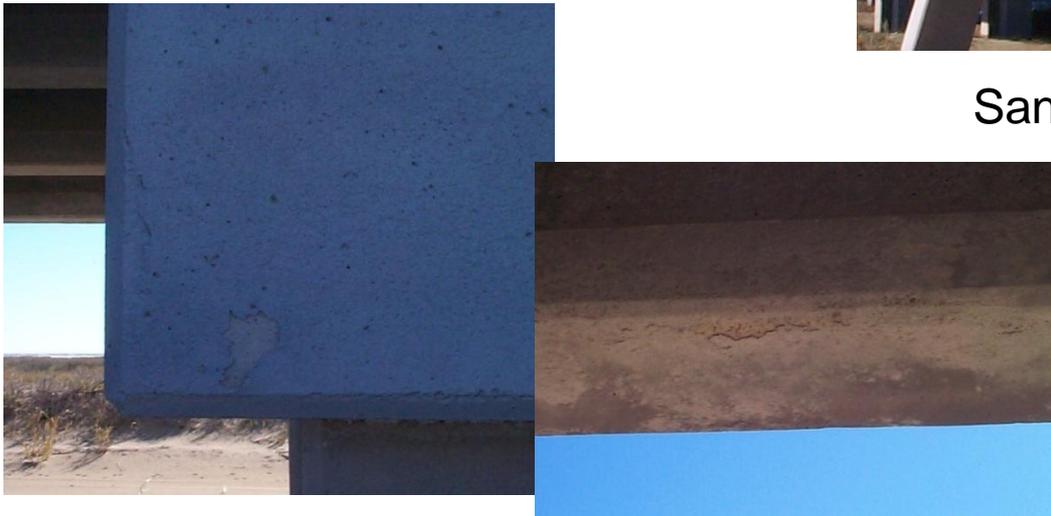
- Completed in 2000
- Zinc Coating - Concrete Deck
- Zinc Mesh Lifejacket
 - Pile Caps Splash Zone/Upper Tidal
- Zinc Bulk Anode
 - Underwater Element of Piles

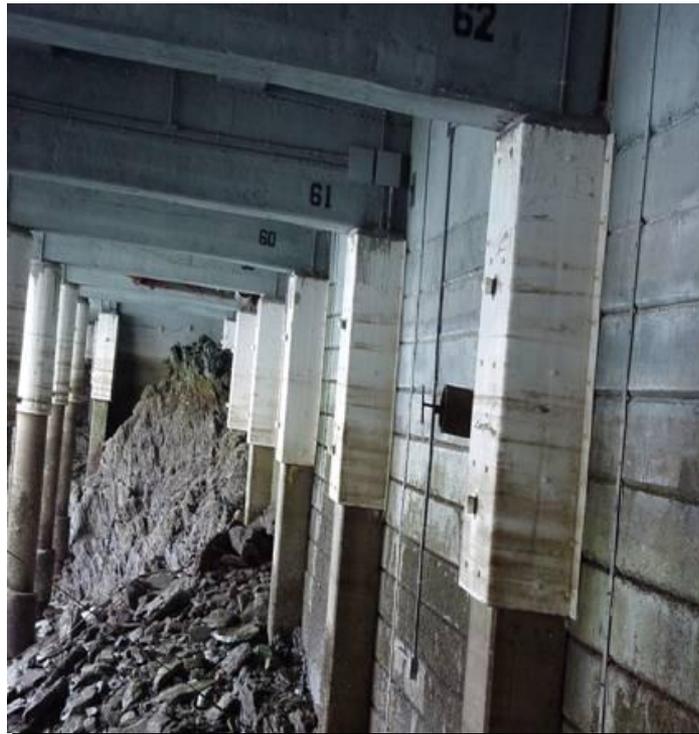
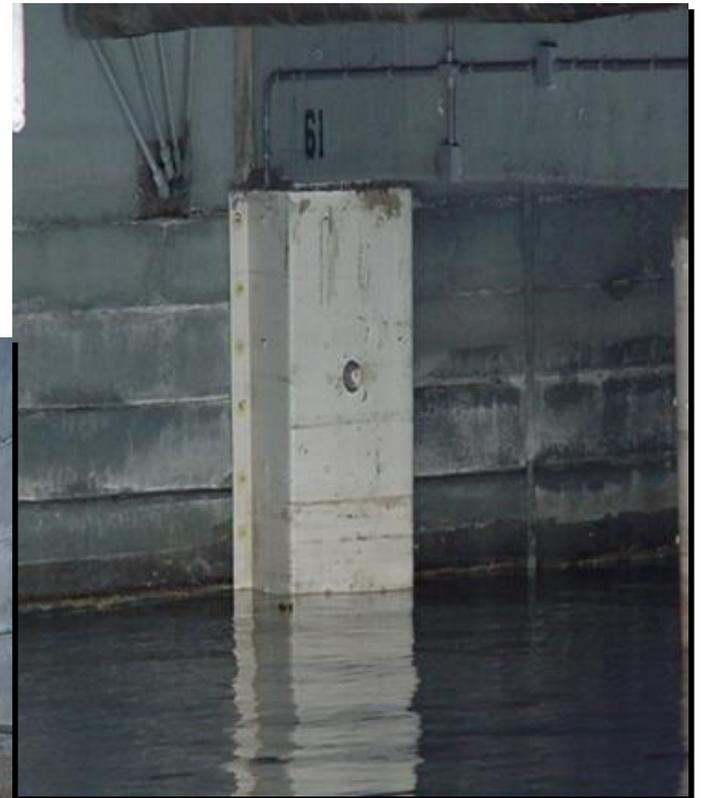
Pilaster Lifejacket™

- Successful CP
- Low Maintenance Cost
- New Phase II of Works 2010
- No Corrosion Evident

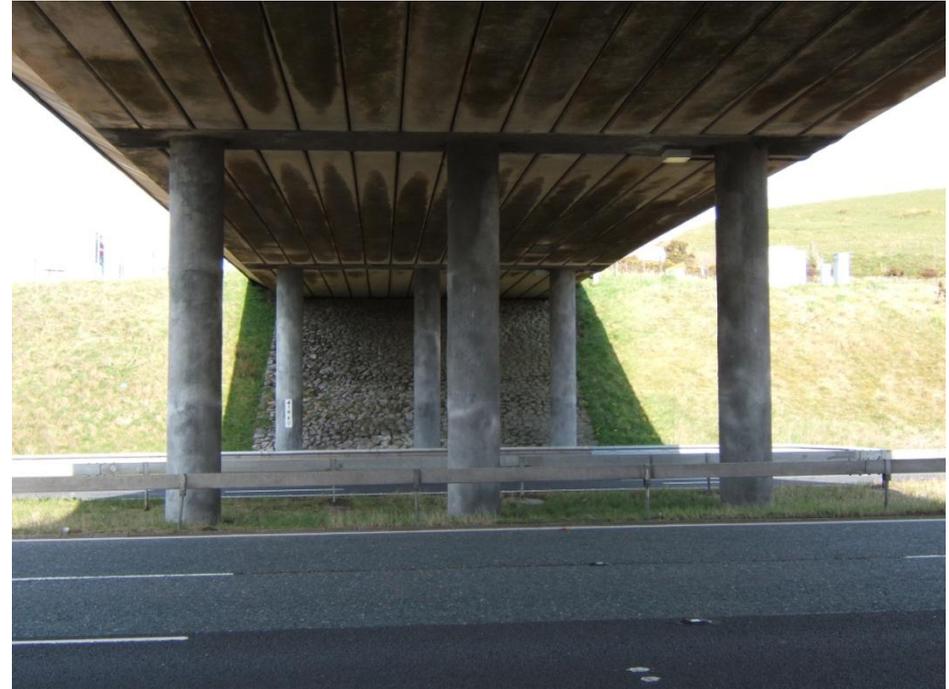
Sedbergh Road Interchange Bridge UK

- January 2003
- High Chloride Levels 4.83% by weight of cement
- Three anode zones
Crosshead, Lower Column, Upper Column
- Type 300 Ti Mesh Crosshead
- Type 150 Columns
- 24 Reference Electrodes

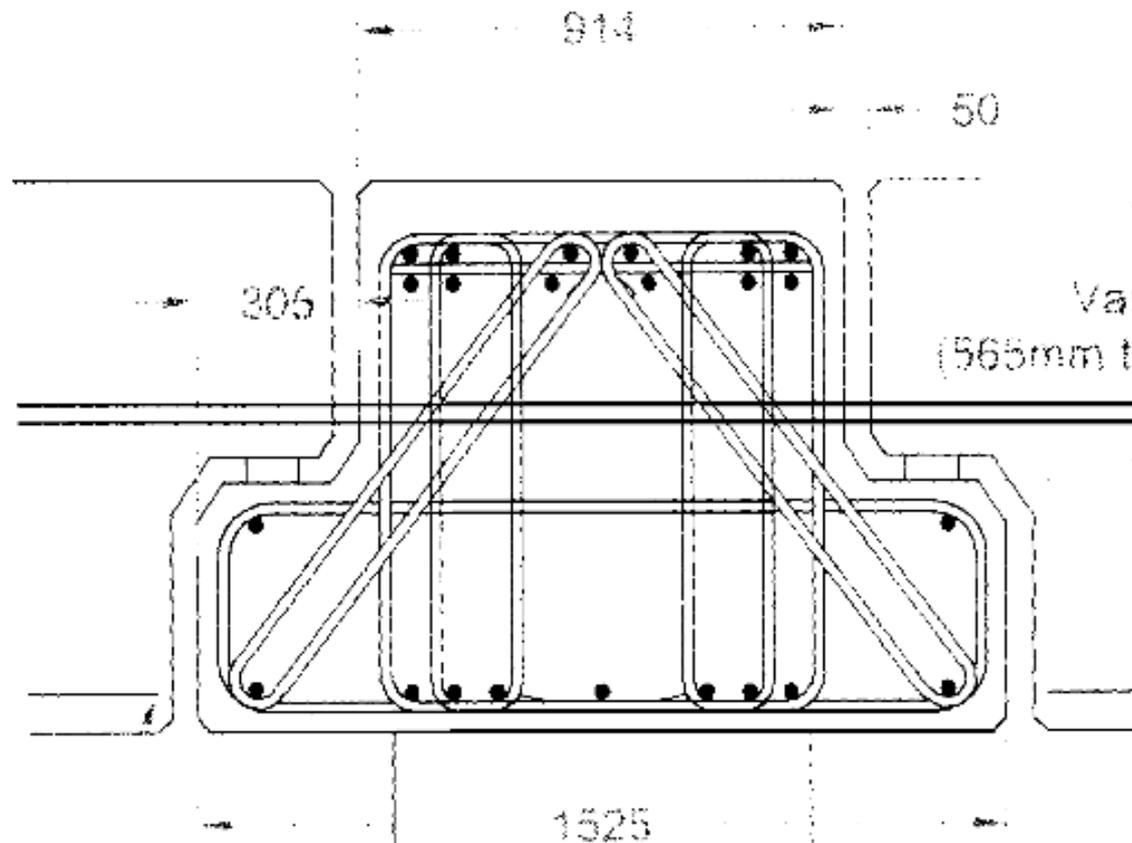
- Inverted “T” Construction
- Steel/Concrete Area Ratio 5:1
- Protection Designed for Full Depth

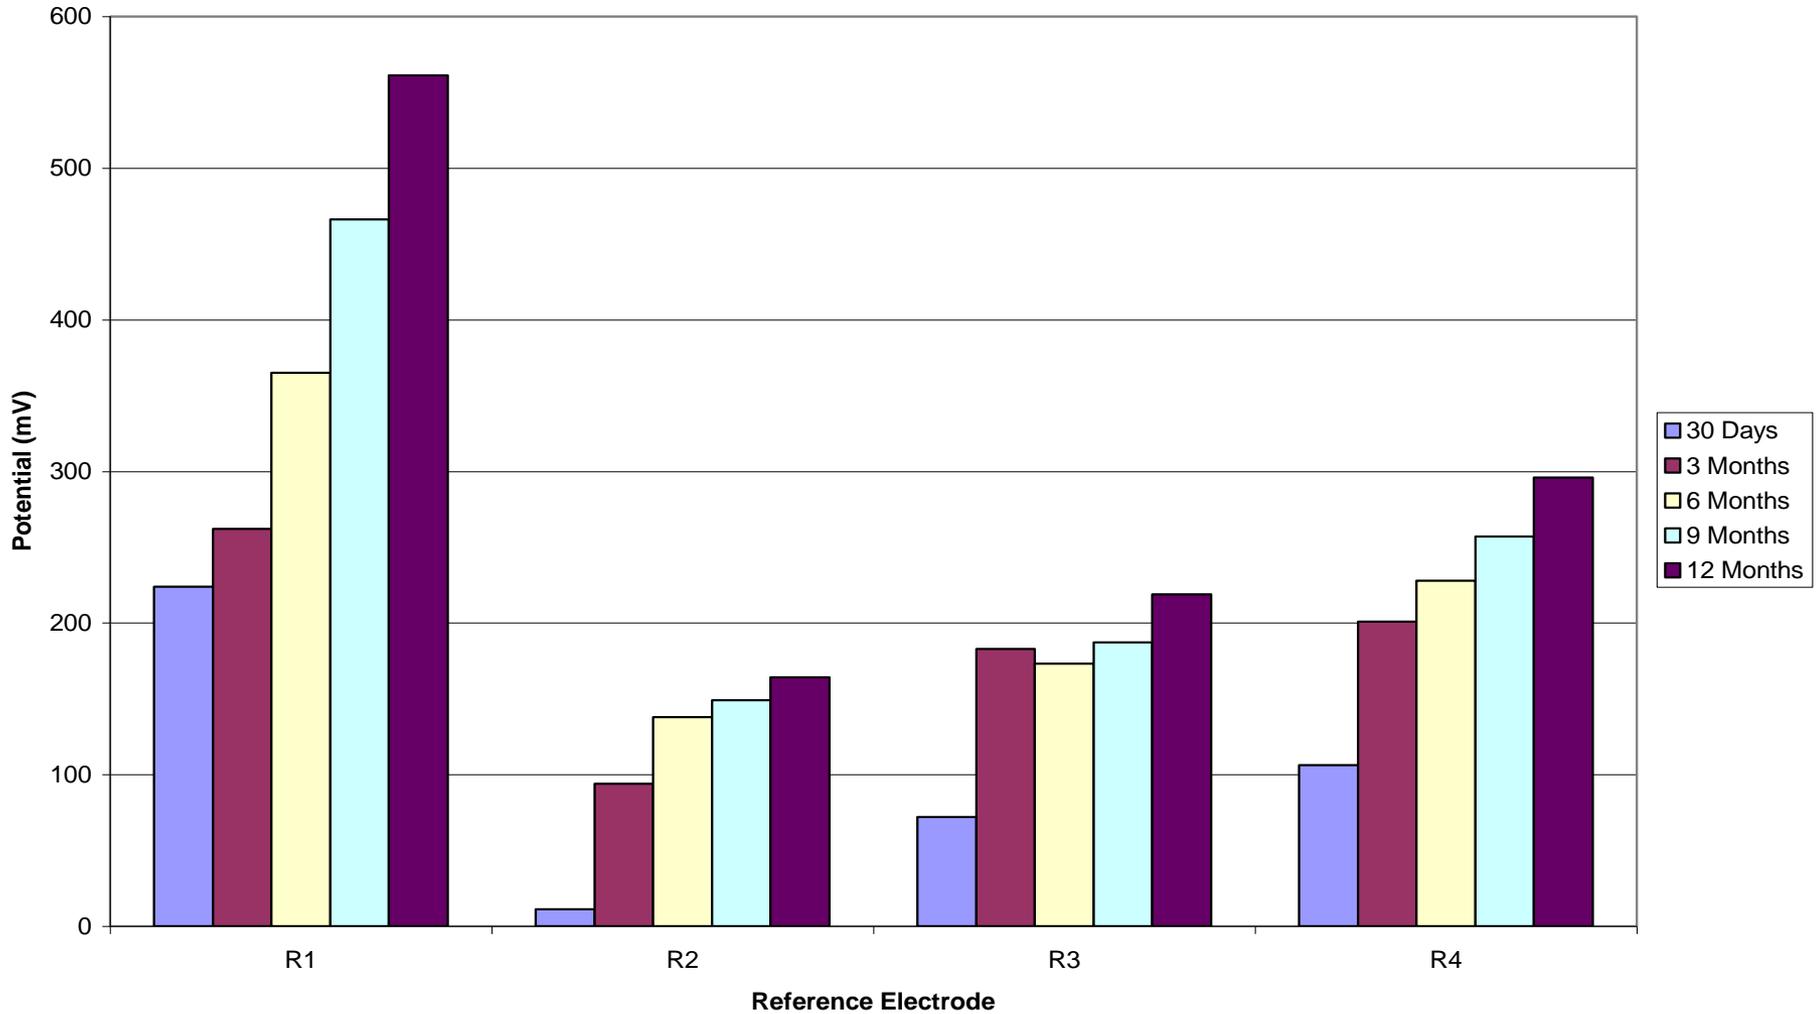
Polarisation Assessment Sedburgh Road Interchange
Zone 2 Central Pier

➤ R2 at 900mm Depth

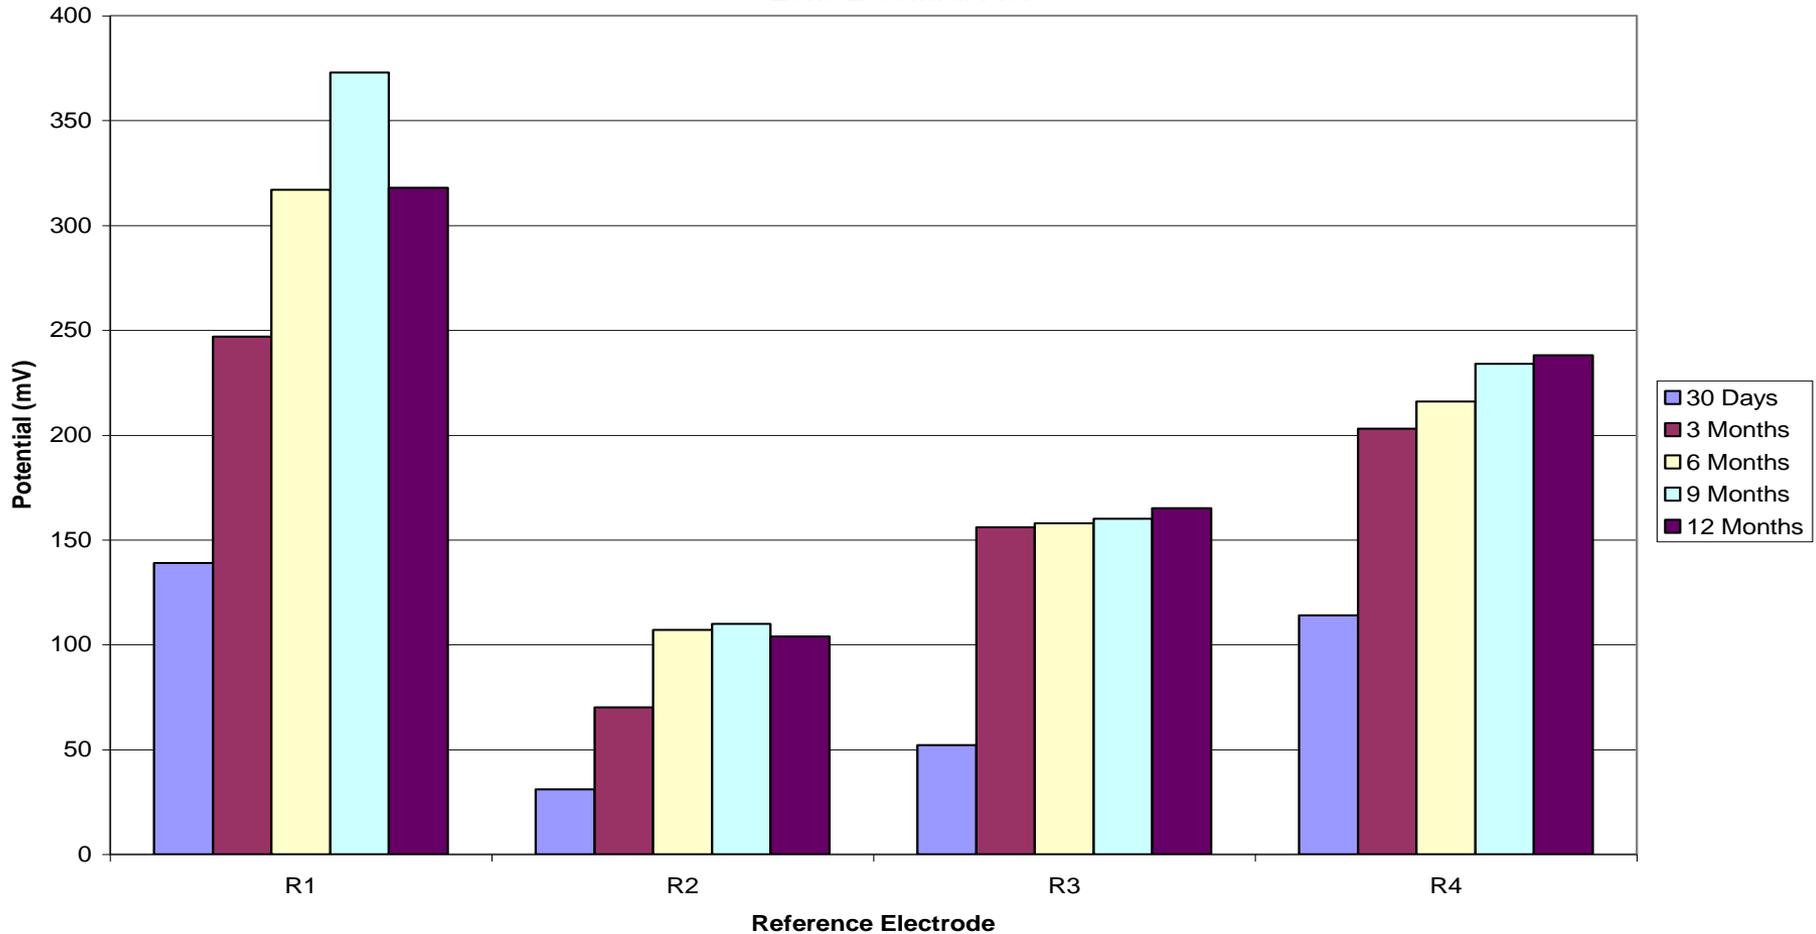
Depolarisation Assessment Sedburgh Road Interchange
Zone 2 Central Pier

➤ R2 at 900mm Depth

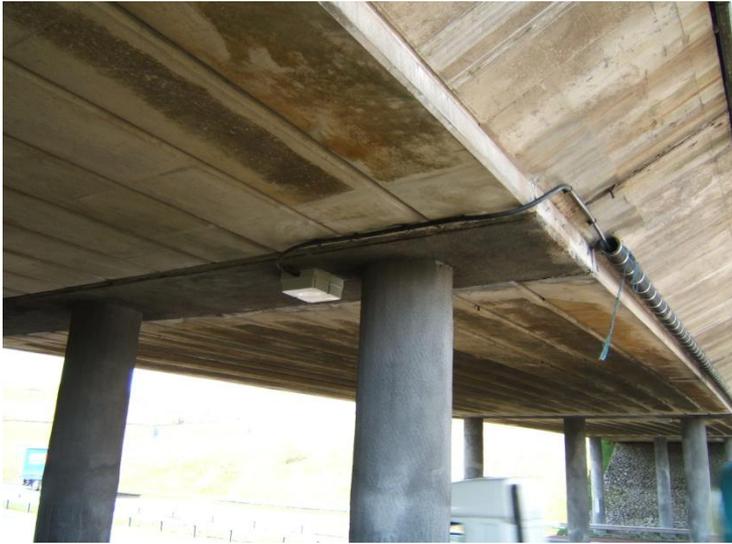
Seven Year Inspection of Anode System

- ✓ There are no reported defects in the anode system during the recent inspection carried out in 2010.
- ✓ Proven to be a very durable system based on design requirements and its atmospheric exposure

- Inverted “T” Construction
- Steel/Concrete Area Ratio 5:1
- Protection Designed for Full Depth
- Operating Current Densities High - Varied between 5.45mA/m^2 during the first year of operation and is now currently operating at 11.76mA/m^2

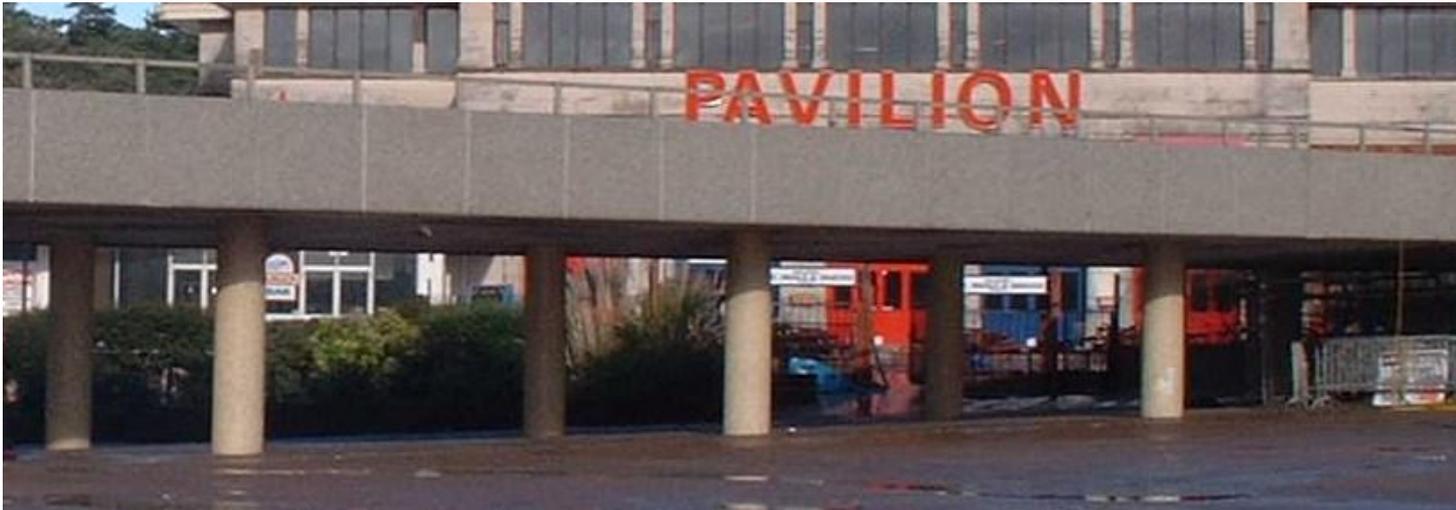
Pier Approach Bournemouth UK

- December 2002
- Concrete Surface Area 616.7m²
- Four anode zones
- Anode Type LD25 Ti Mesh
- 8 Reference Electrode
- Marine Exposure

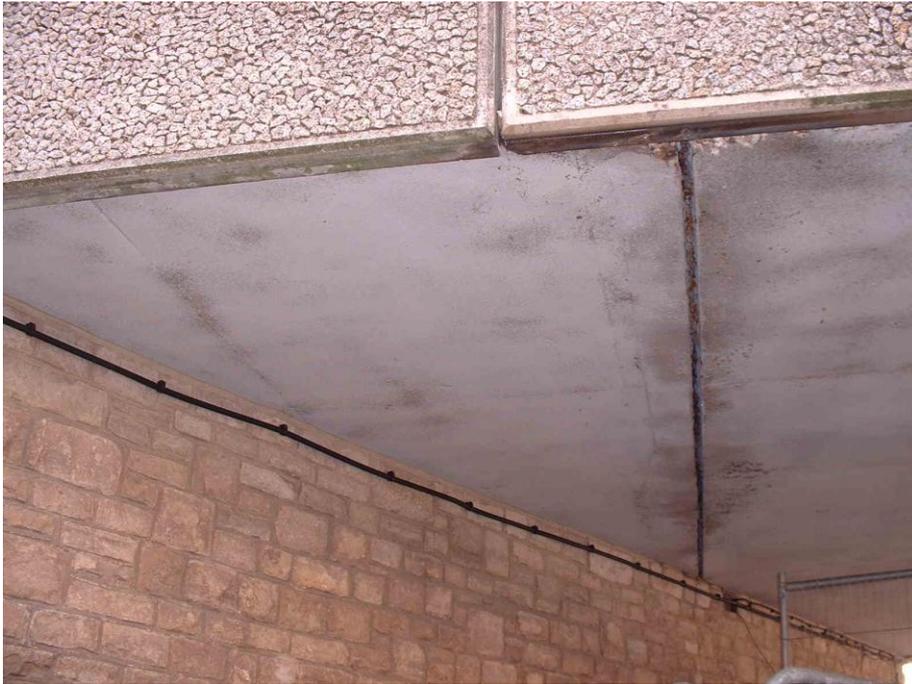
Seven Year Surface Inspection of Overlay

- ✓ No defects in the anode system during the recent inspection carried out in 2010.
- ✓ Proven to be a very durable system based on design requirements and marine exposure

- ✓ Afforded adequate cathodic protection levels for the past 7 years.
- ✓ Current densities varied in the range of 1.45mA/m^2 during the first year of operation and are now currently operating at 13mA/m^2 .

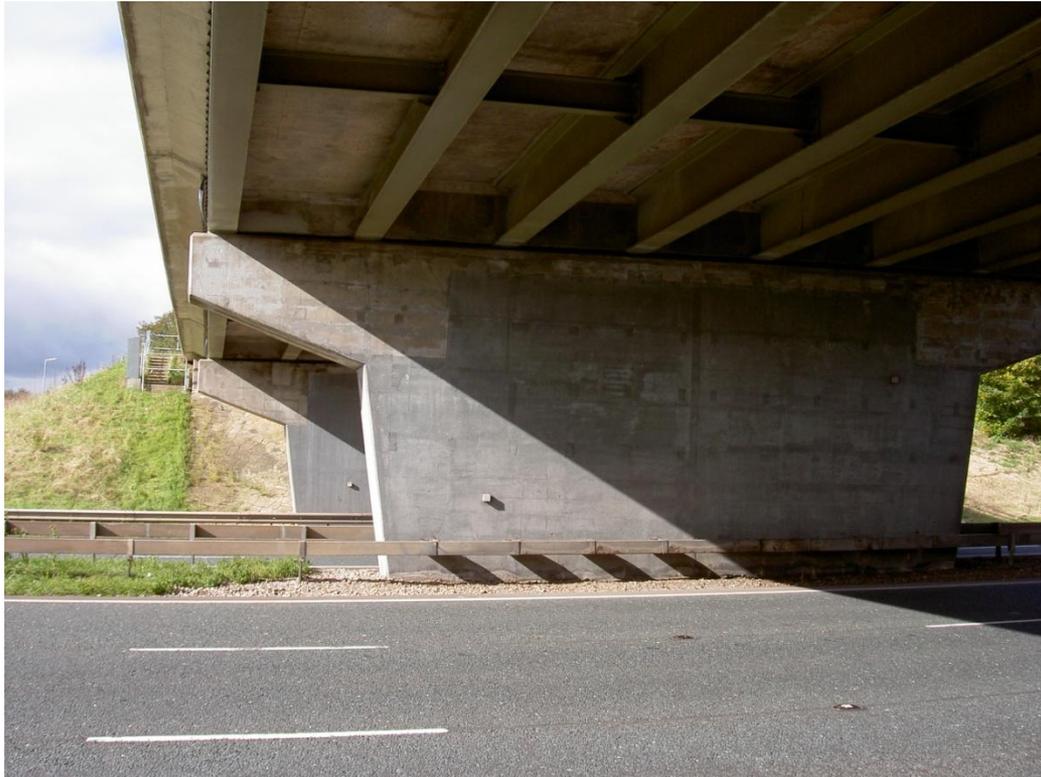
Golden Fleece Cumbria UK

- January 2003
- 4 Piers Protected
- 12 Anode Zones
- Various Anode Types
- 50 Reference Electrodes
- 32 Temperature & Humidity Sensors

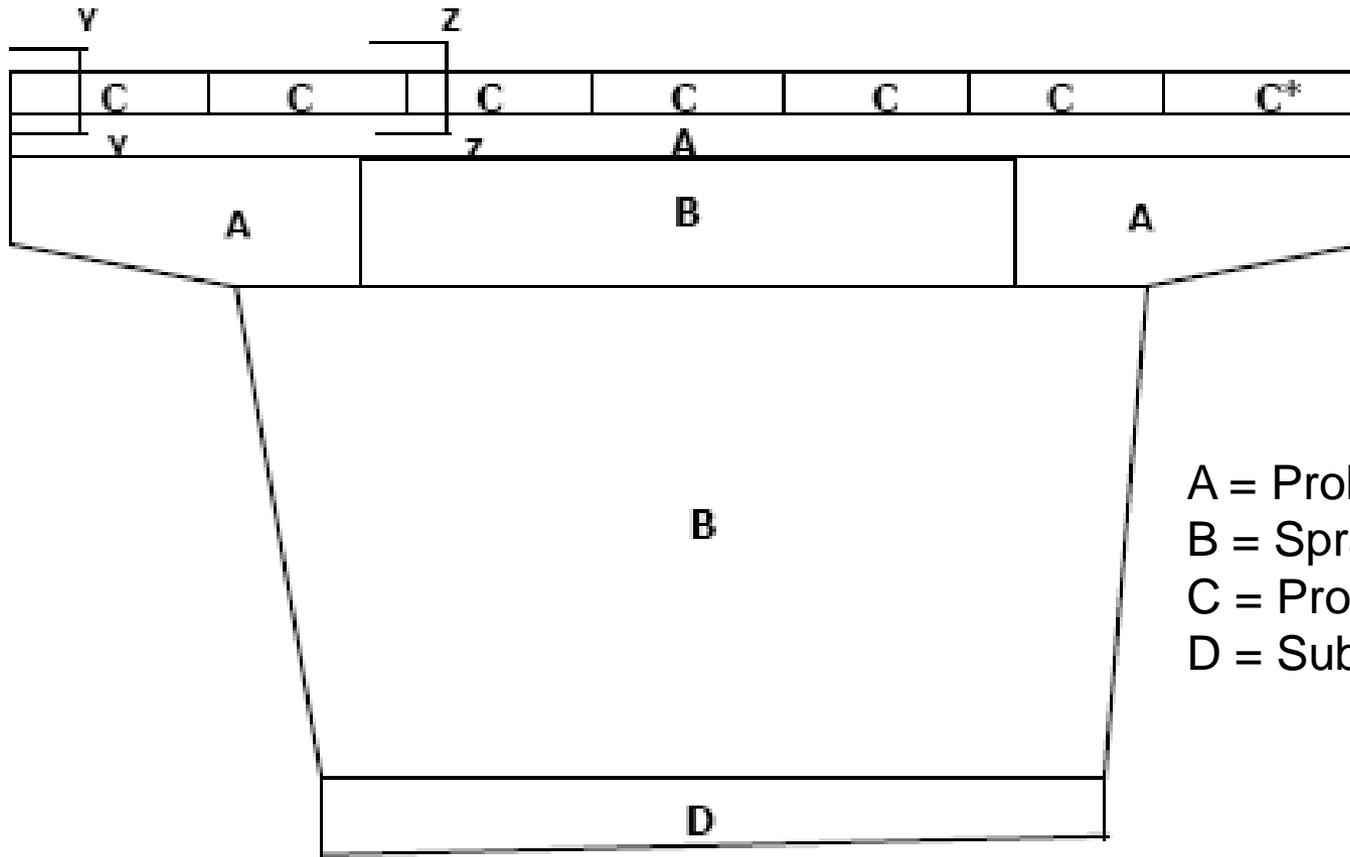
Anode Zone layout Golden Fleece

- A = Probe Anodes
- B = Sprayed Zinc
- C = Probe Anodes
- D = Submerged Anode

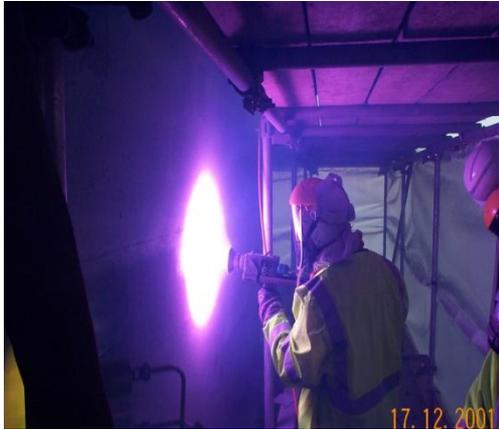
- Sprayed zinc thickness of $400\mu\text{m}$ - $500\mu\text{m}$.
- High purity zinc 99.9%
- Electric arc thermal spray.

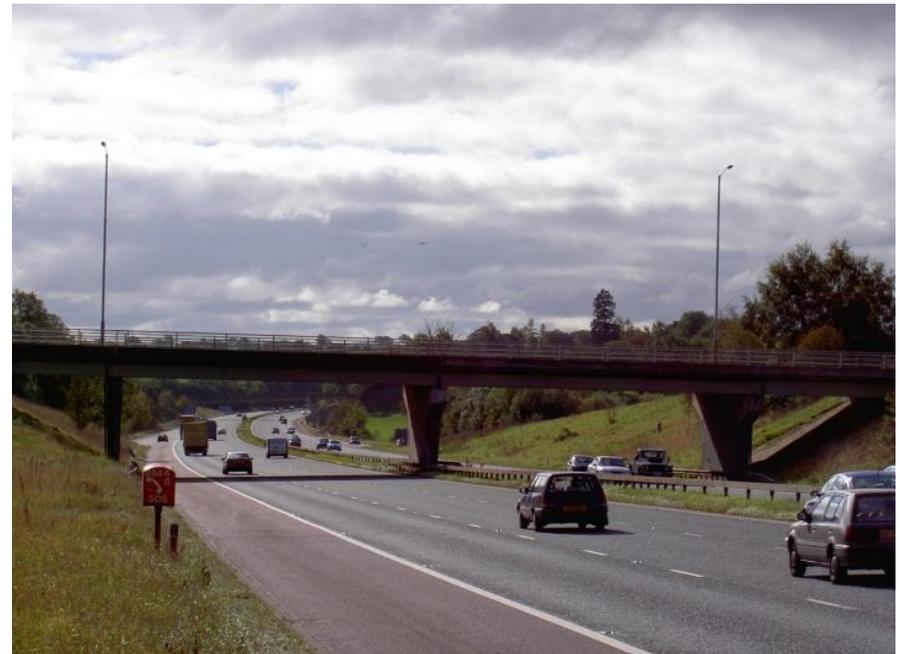
- Constant current mode
- Current density of $5\text{mA}/\text{m}^2$.
- Current density reduced since energising

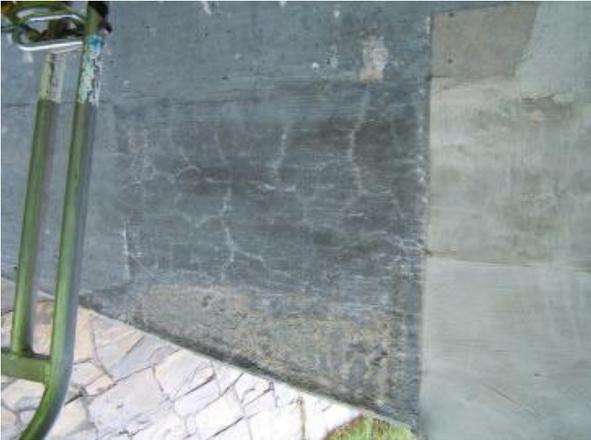
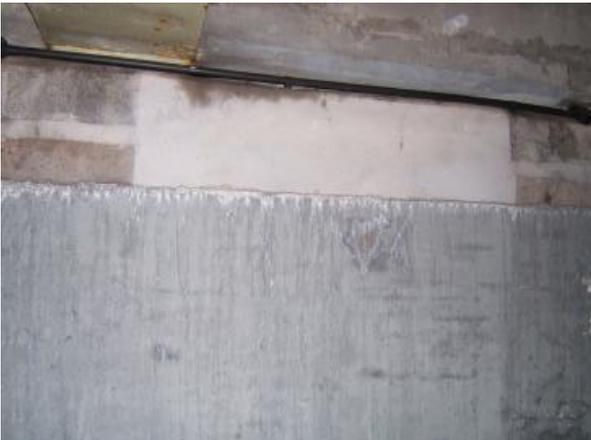
- Zinc De-bondment Found Caused by Low Resistivity Repair Material
- No Loss in Protection from De-bondment.
- No Noticeable Increase in De-bondment on Recent Inspection
- Probe Anode Extremely Effective
- Reduced Current Density Design Avoiding Acidification

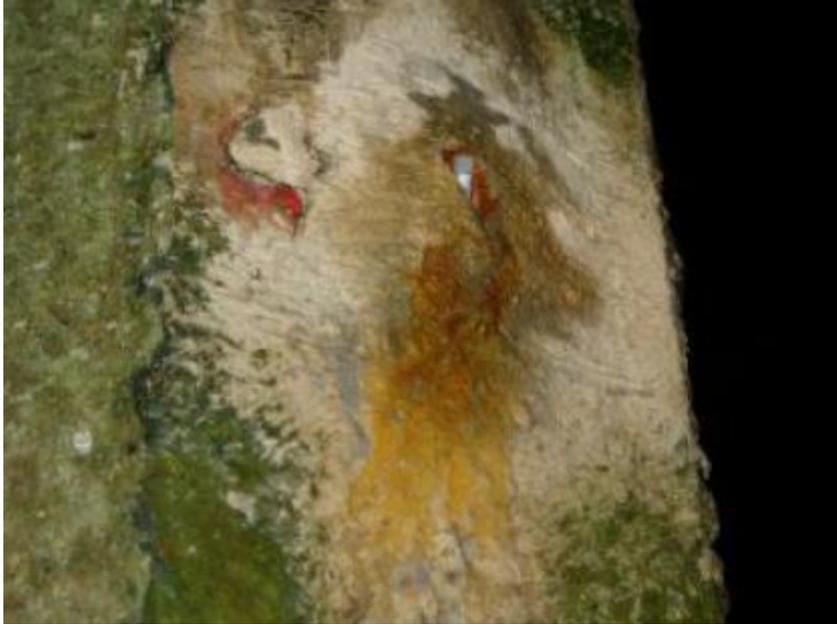
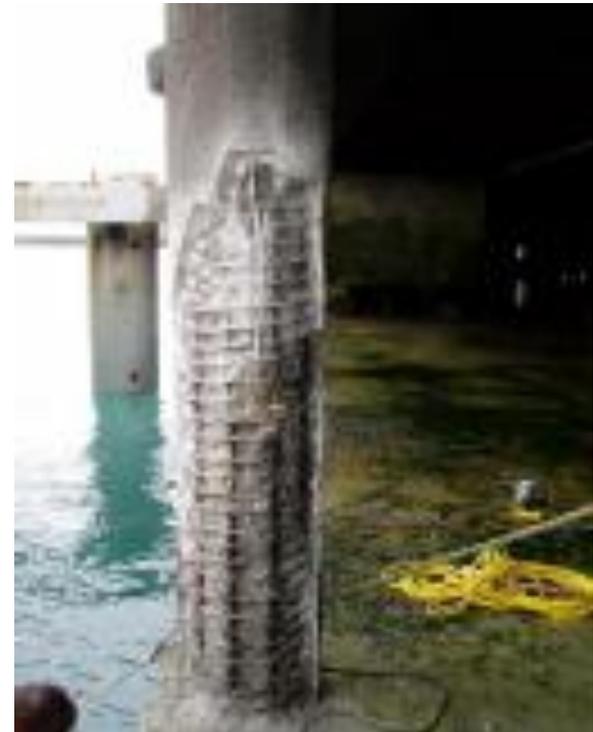
- Marine structure
- Tidal Range 20ft
- Anode Ribbon Design
- Column Pile Protection

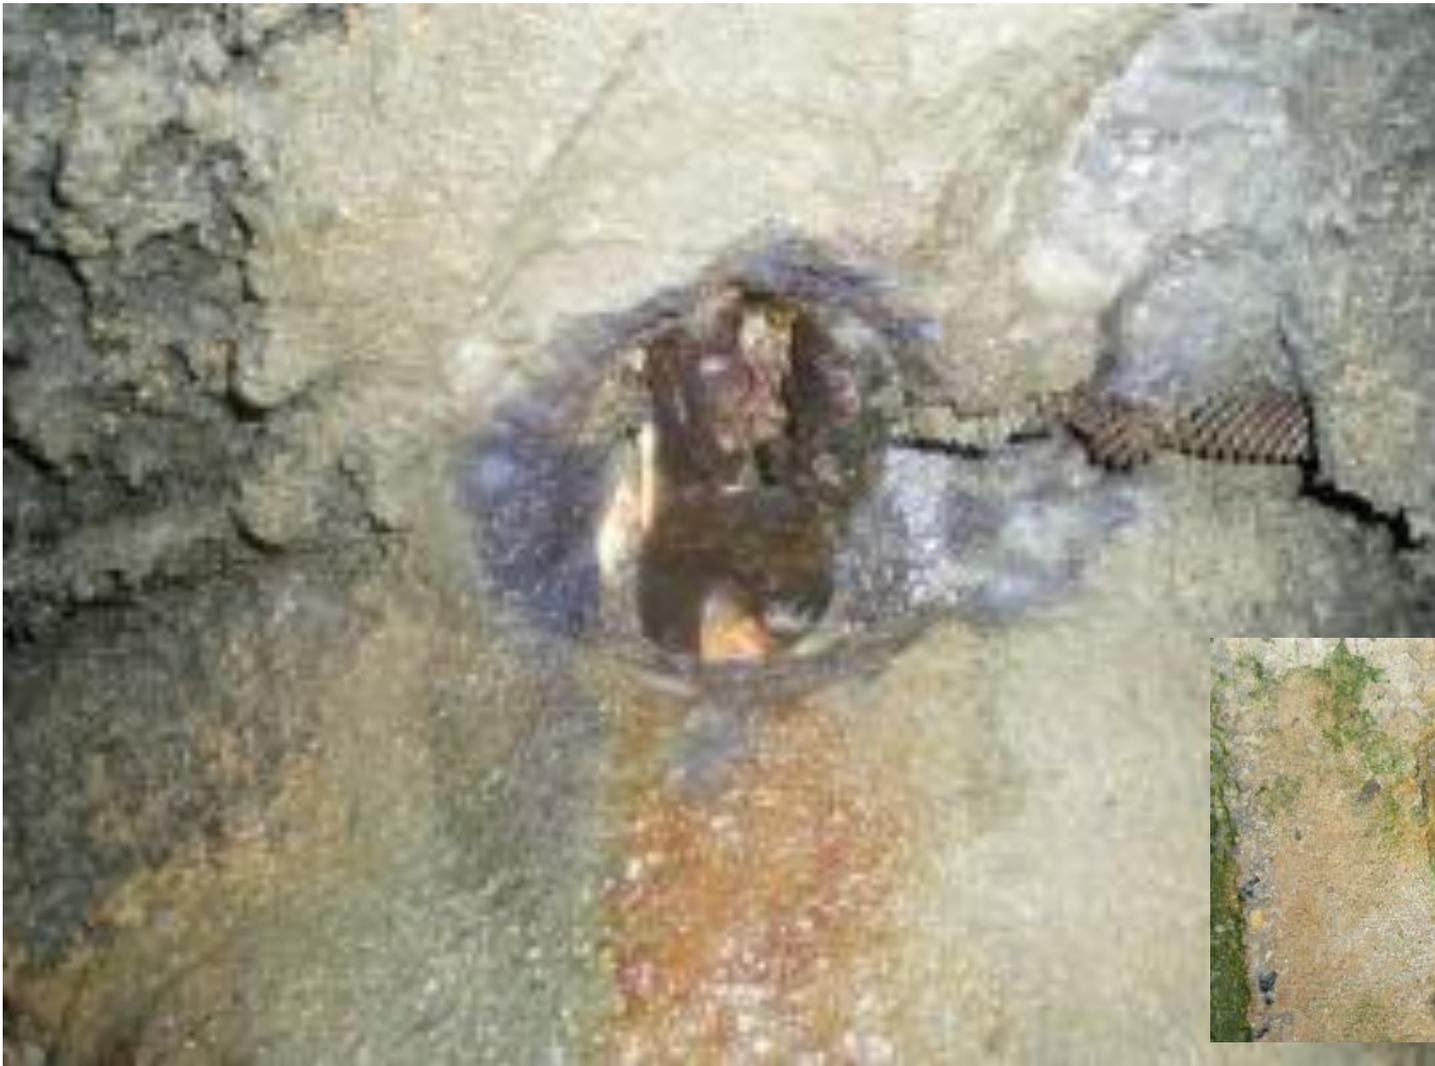
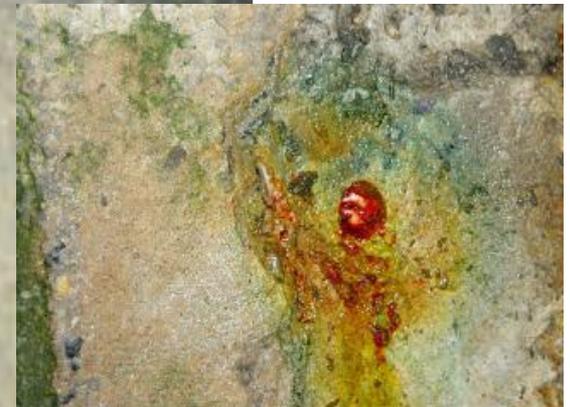
- Multiple Failures
- Poor Installation
- Low Cover Anode Connection $< 5\text{mm}$
- Major Acidification Due to Current Dumping
- pH of < 5 at Connection points
- Cover $> 40\text{mm}$ Connections Good

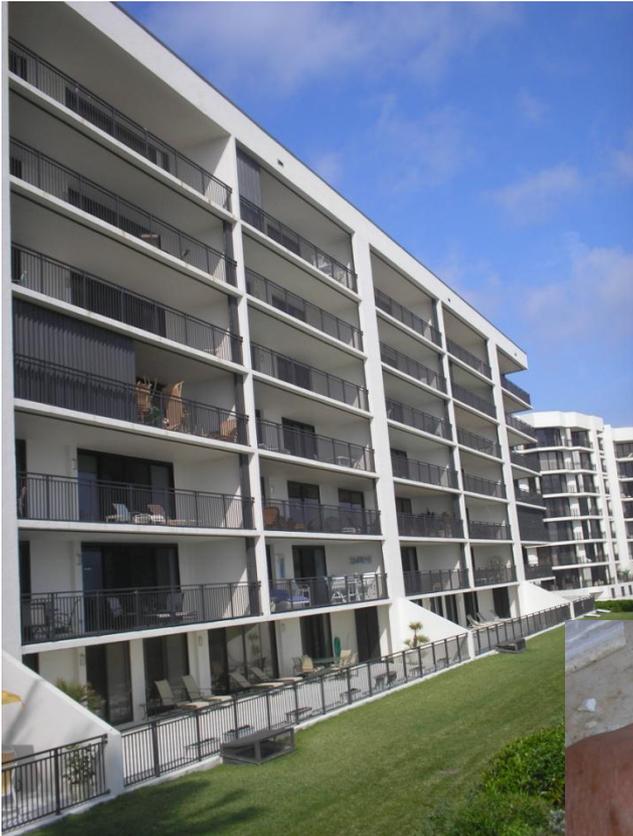
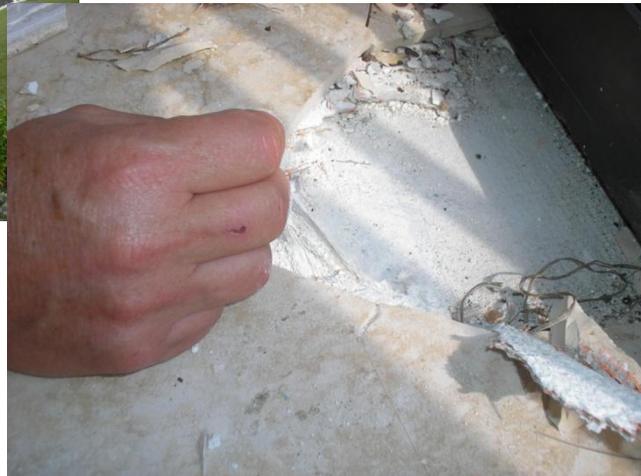
Surface Applied Zinc Sheet

- Coastal Structure
- Balcony Protection
- Chloride Problem
- Zinc Sheet Design
- Two Types of Covering Used. Tile & Deck Coating

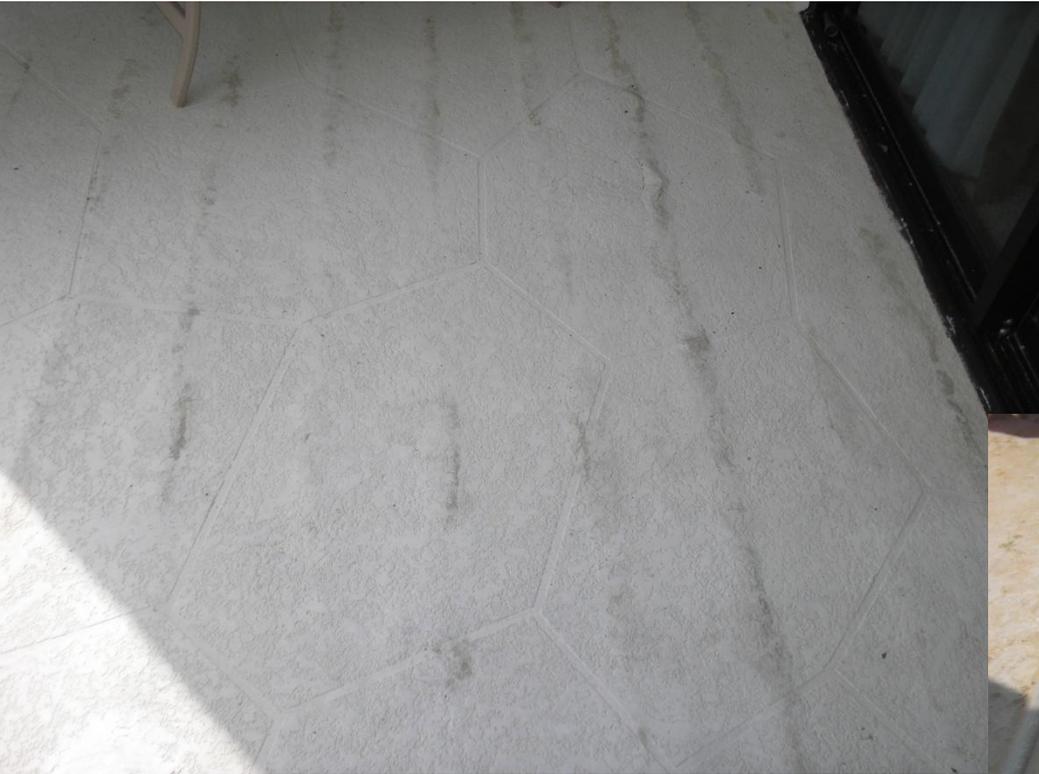
Deck Coating

- Failure on Both Surface Finishes

- Blistering of Surface Coating
- Jacking of Surface Tiling
- Non Breathable System
- Large Moisture Vapour could not escape
- Product Sale
- Little to No Engineering Carried Out
- Current Mapping Not Understood
