# Internal Linings for Vessels and Tanks

Presented By : Mr Ron Campbell  
Belzona Polymerics Ltd

18<sup>th</sup> May 2014

**WORKSHOP**  
COATING AND LINING  
for Industrial Application

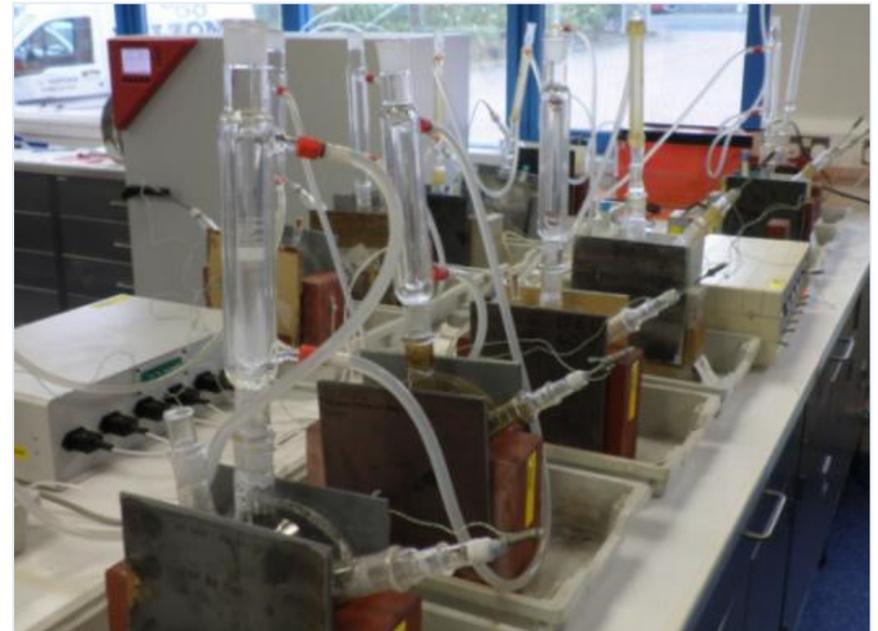
## ➤ NACE TM0174: Atlas Cell Immersion

- Glass cells up to 95°C / 203°F
- Steel pressure cells up to 180°C / 356°F
- Minimum 6 months test

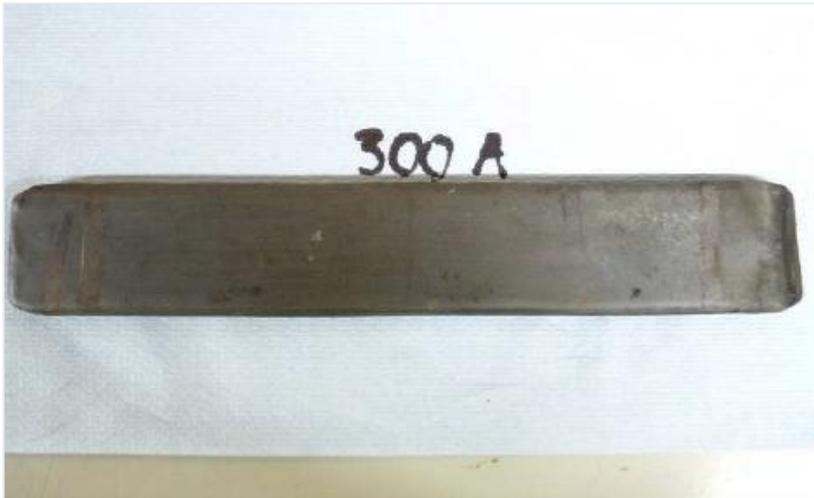
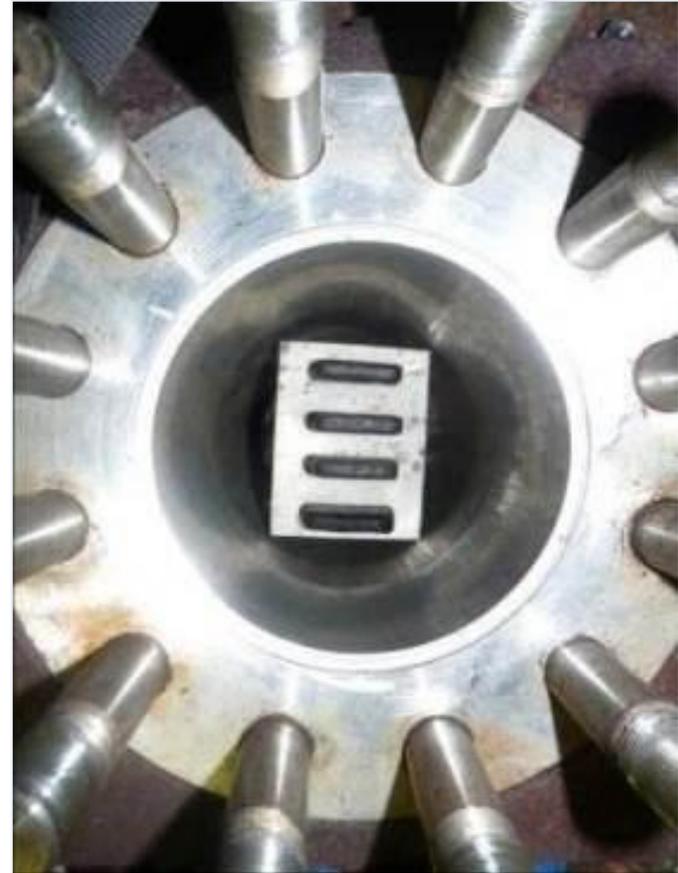
- Resistance To Steam-Out
  - Autoclave
  - 96 hours
  - Up to **210°C / 410°F**

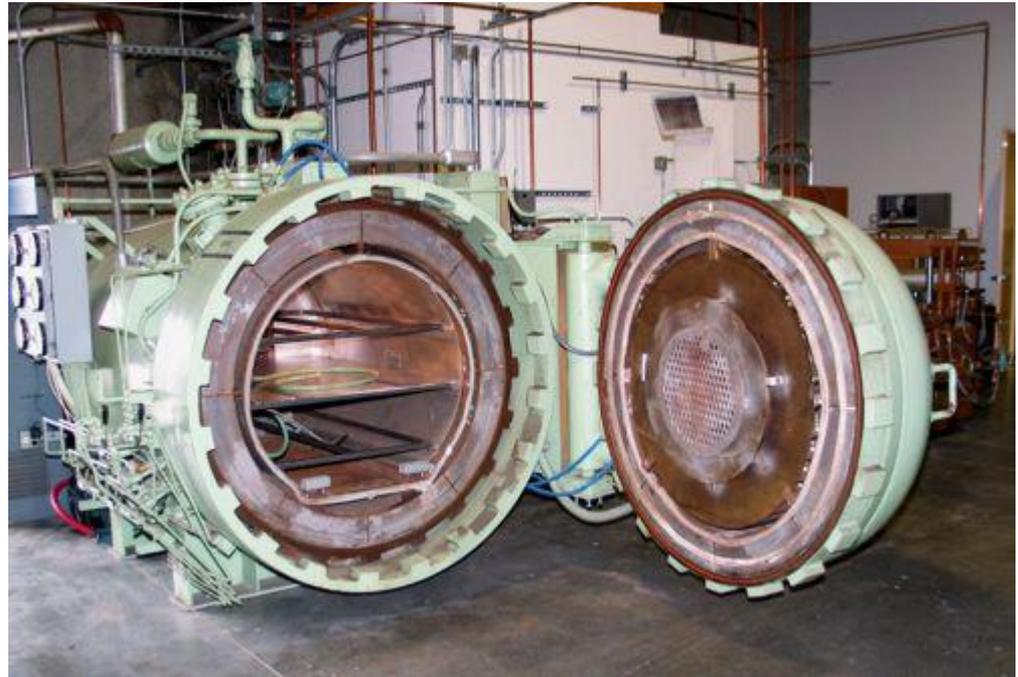
## ■ NACE TM0185 Rapid Decompression

100 bar (1450 psi)

Reduced to 50 bar (725 psi)

in 5 minutes

Then reduced to atmospheric

in a further 10 minutes

Recommended 5 bar/min

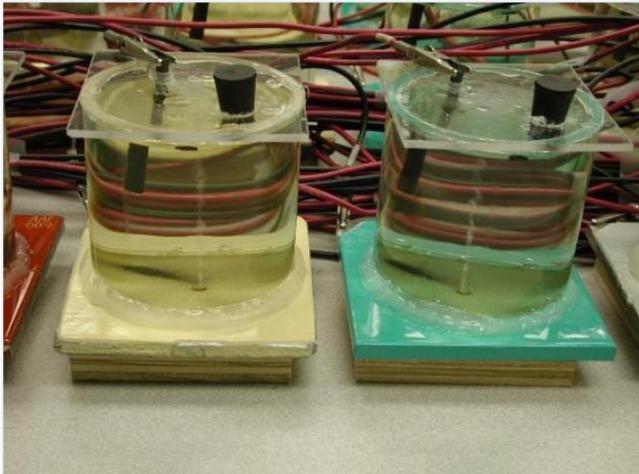
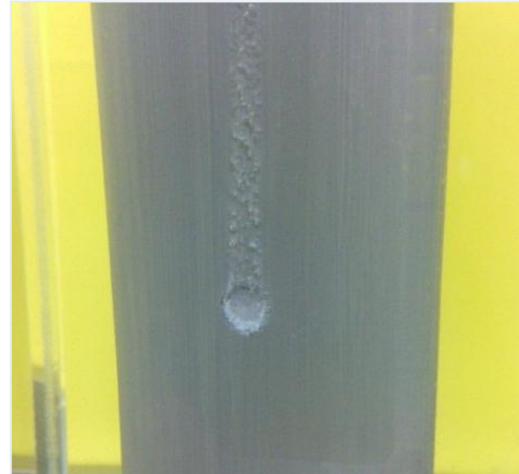
- ASTM G8, G42 or G95
  - 28 day test
  - Elevated temperature ASTM G42 / G95 tests run at temperatures up to 90°C
- Radii as low as **2.5 mm at 80°C / 176°F**

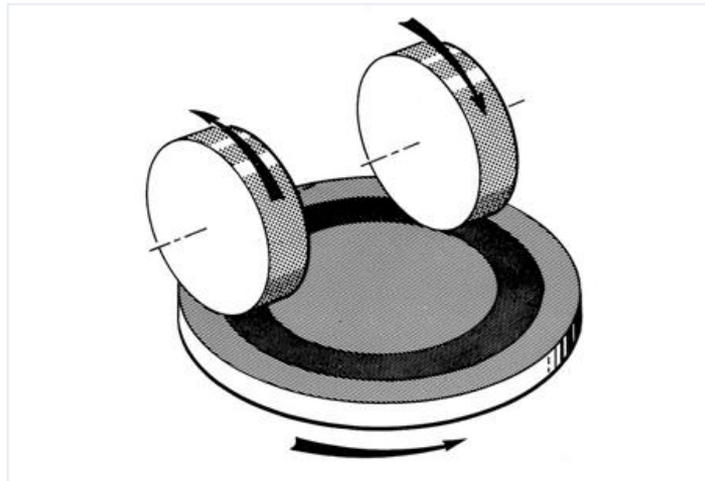
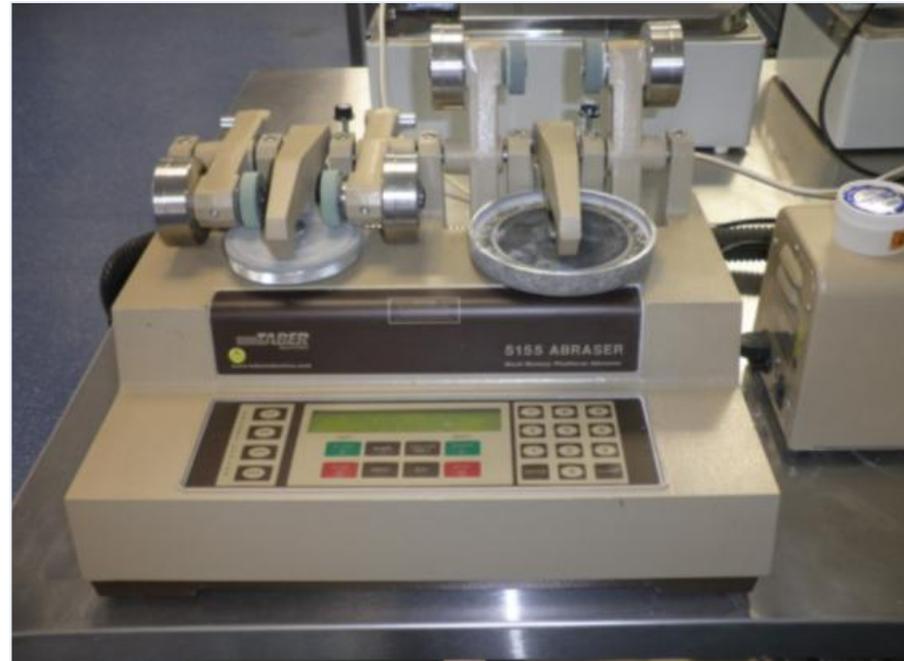
## ■ ASTM D4060: Taber Abrader

- Sliding abrasion
- 1 kg load, 1000 cycles
- Wet or dry test

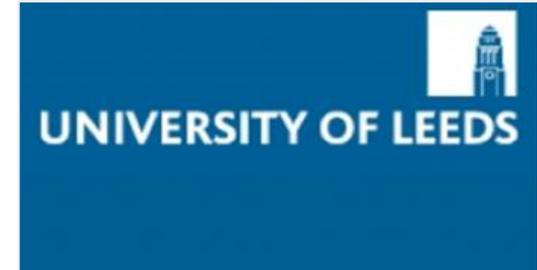
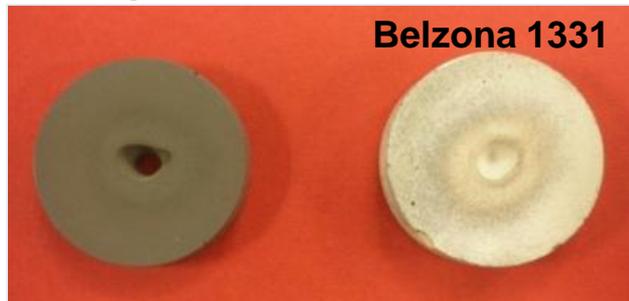
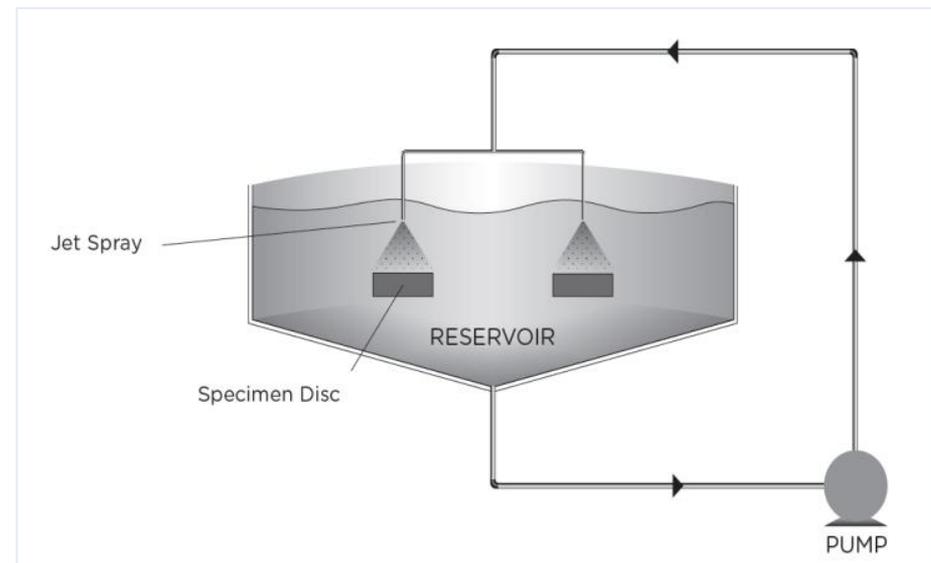
- Leeds University Slurry Jet
  - Impact abrasion
  - Silica sand in water
  - 100 hours at 20 m/s flow rate
  - 90° impact angle
  - Up to 70°C

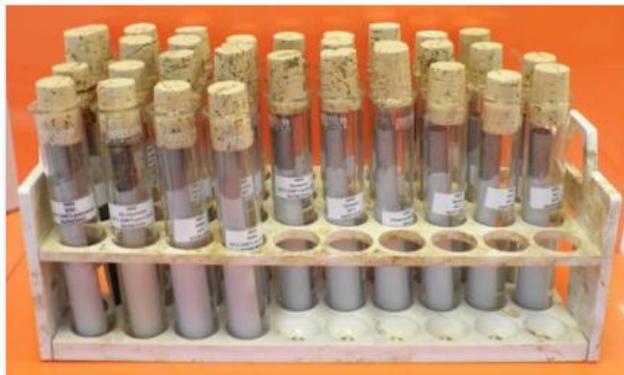
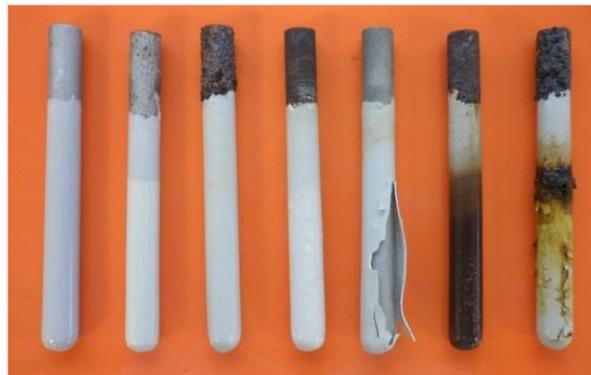
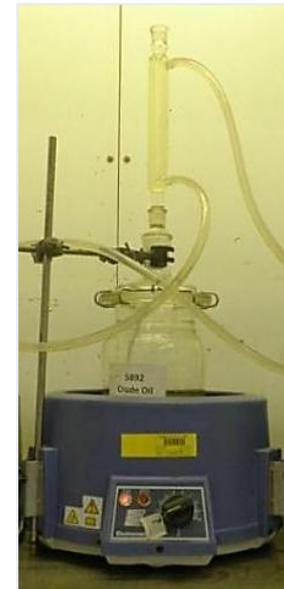
- ISO 2812-1
  - Coated steel rods
  - Ambient and elevated temperatures
  - Reagents including ethanolamines and other process additives (e.g. Nalco)
  - **12 months immersion**

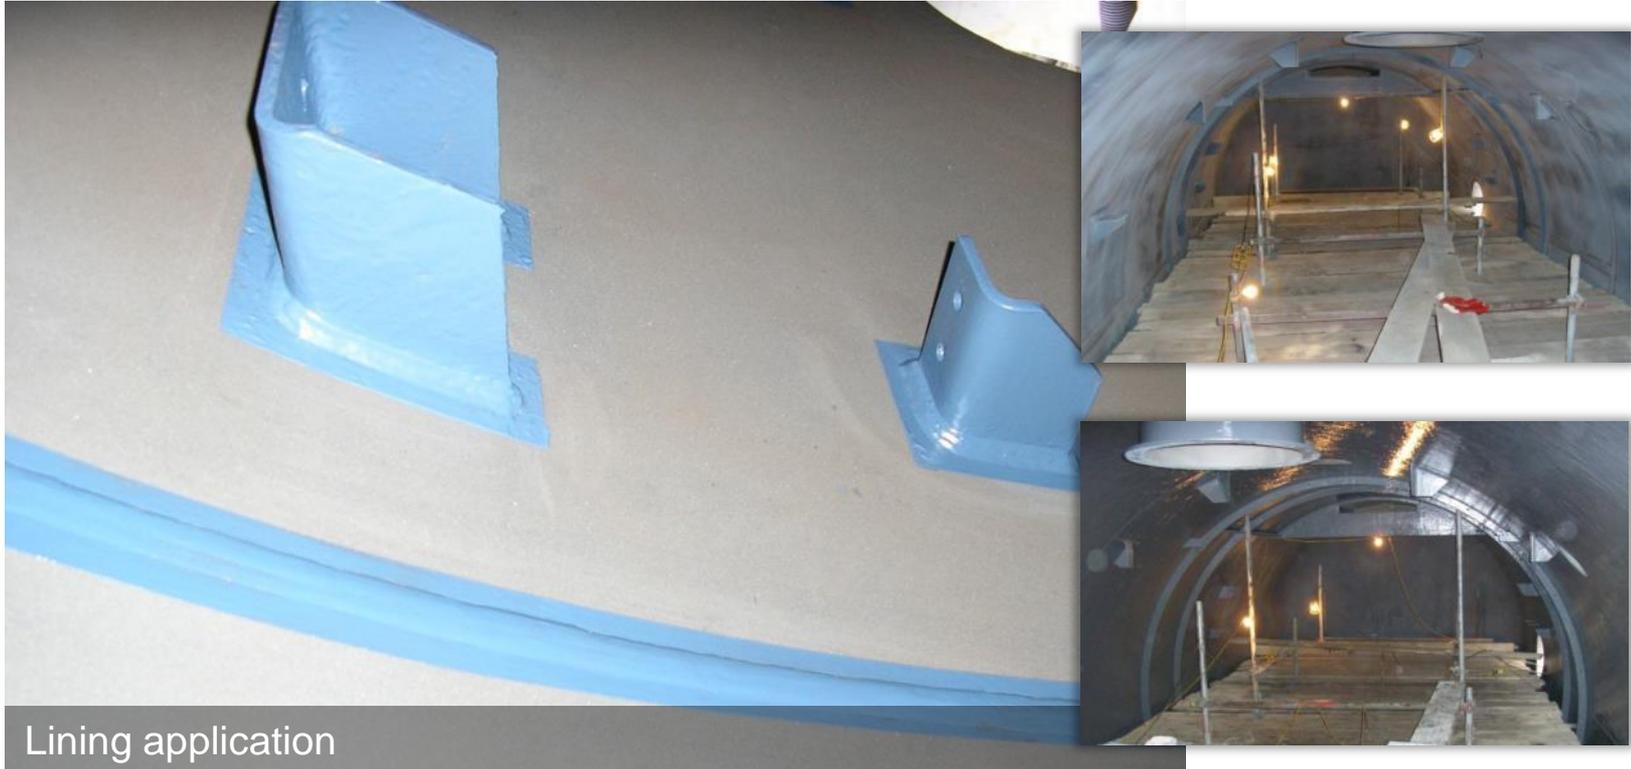
Lining application

The original glass flake coating had failed in service leading to substrate pitting and corrosion.

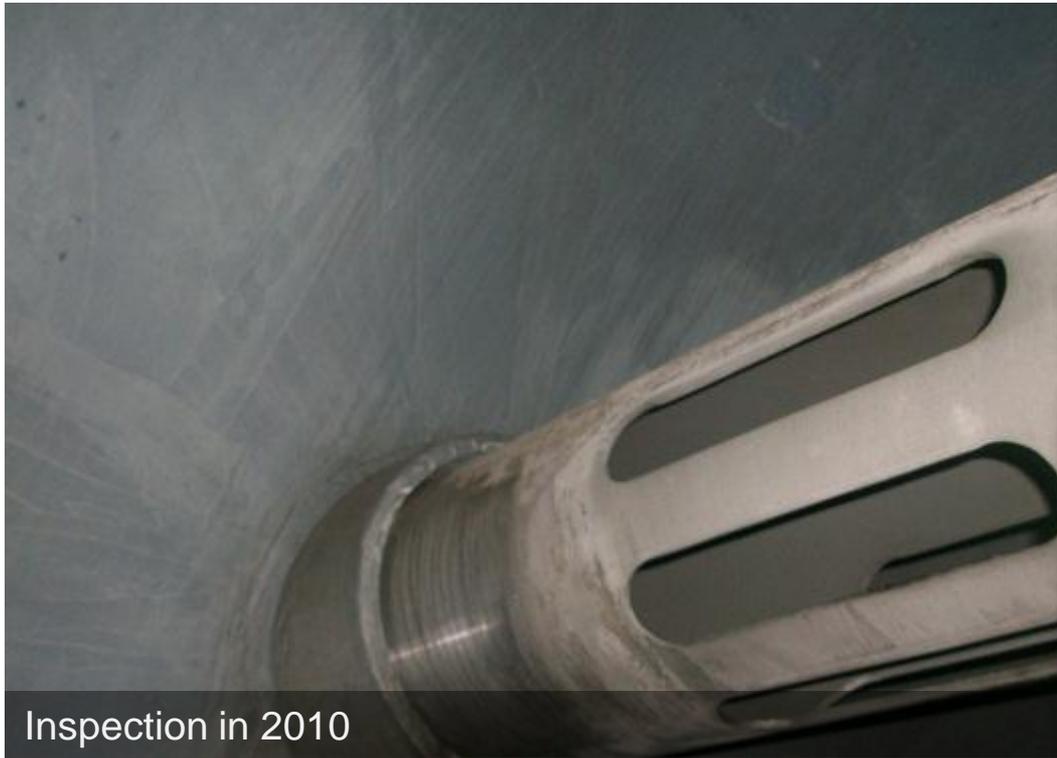
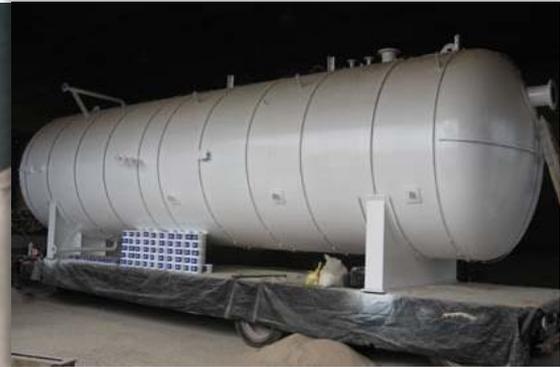
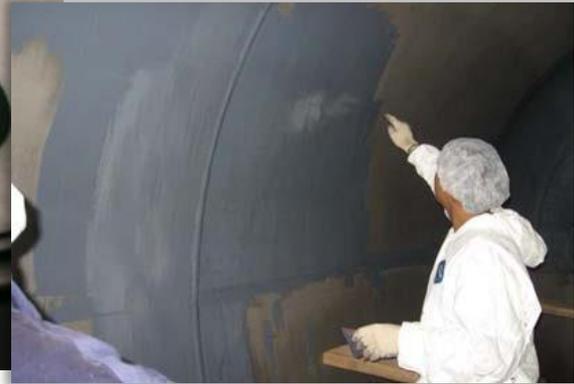
Inspection in 2010

Flash drum to be exposed to diglycolamine, wet  $H_2S$  and  $CO_2$  at  $80^\circ C$ .

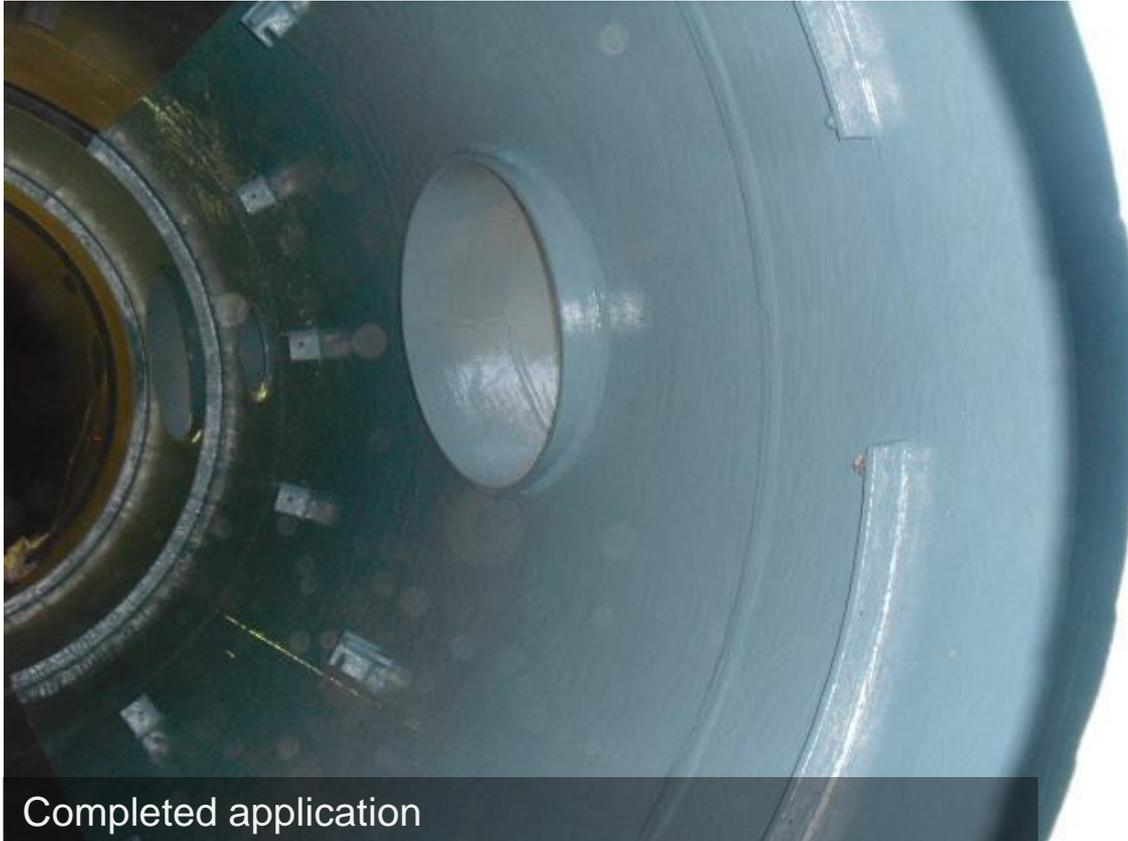
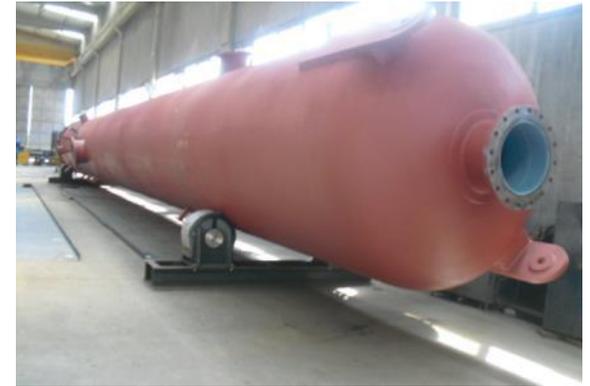
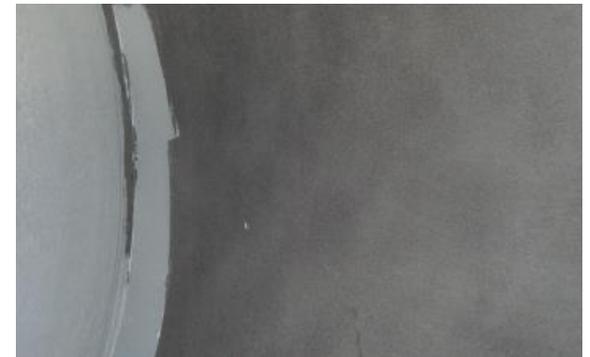
Completed application

Vessel needed protection from hydrogen sulphide and carbon dioxide at operating temperatures of 93°C (200°F)

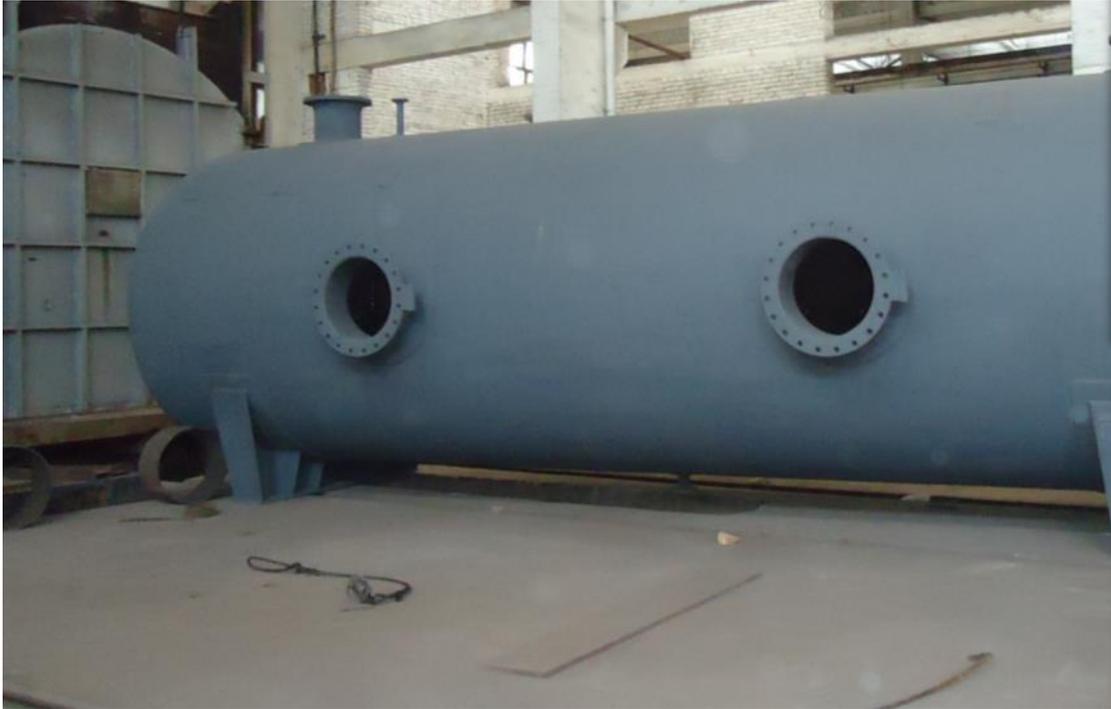
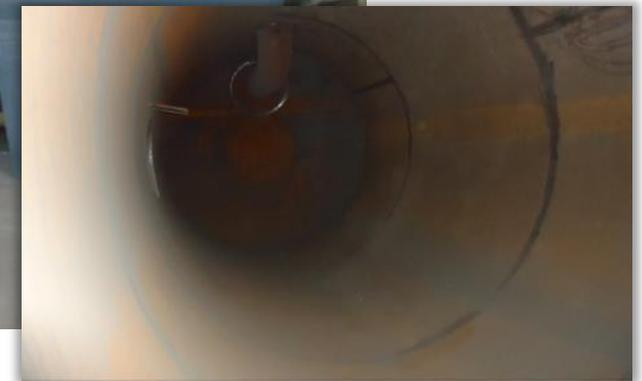
High  $H_2S$  presence in the gas field called for high performance corrosion protection to 32 new build carbon steel vessels.

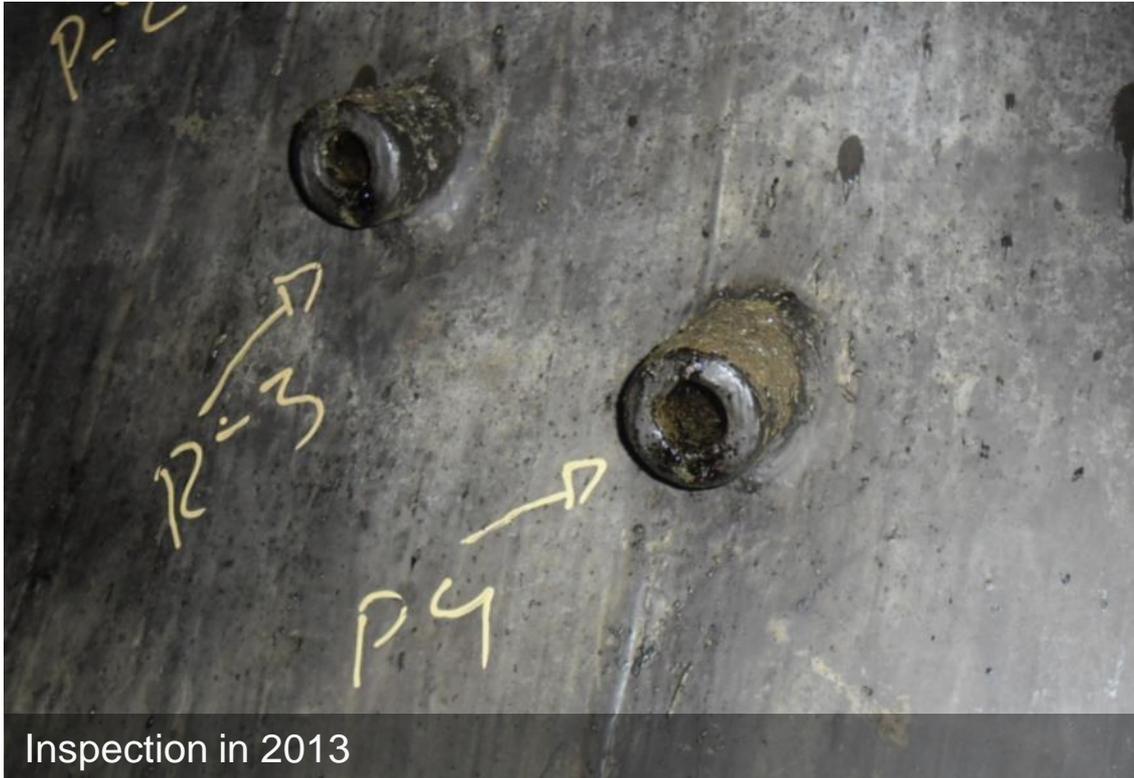
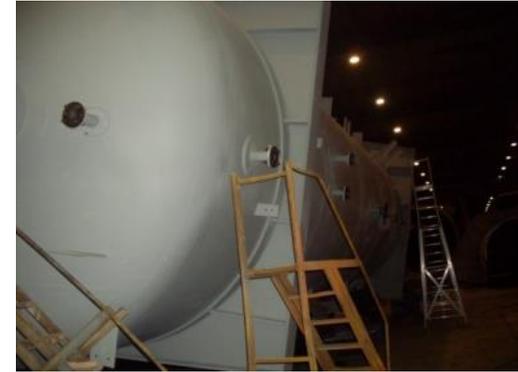
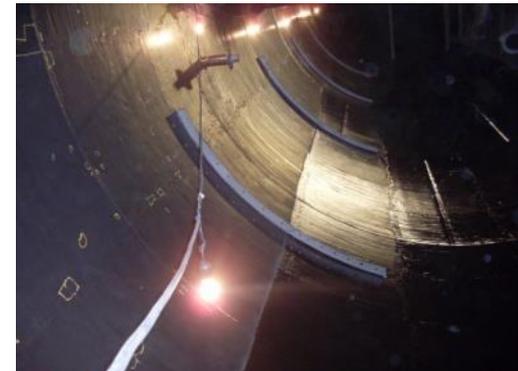
Inspection in 2013

4 pressure vessels - in-service temperatures of up to 180°C. Adjacent flange faces and nozzles also required corrosion protection. Inspected in 2013, all in perfect condition.

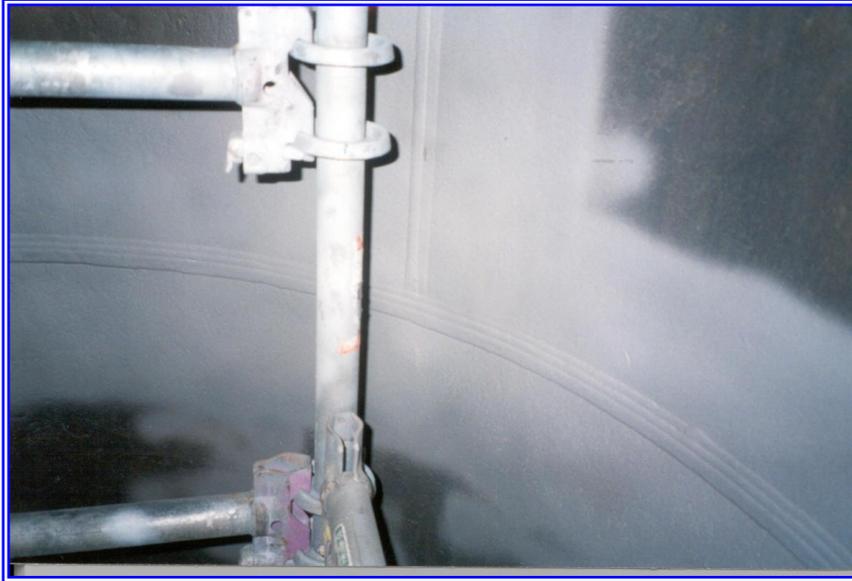
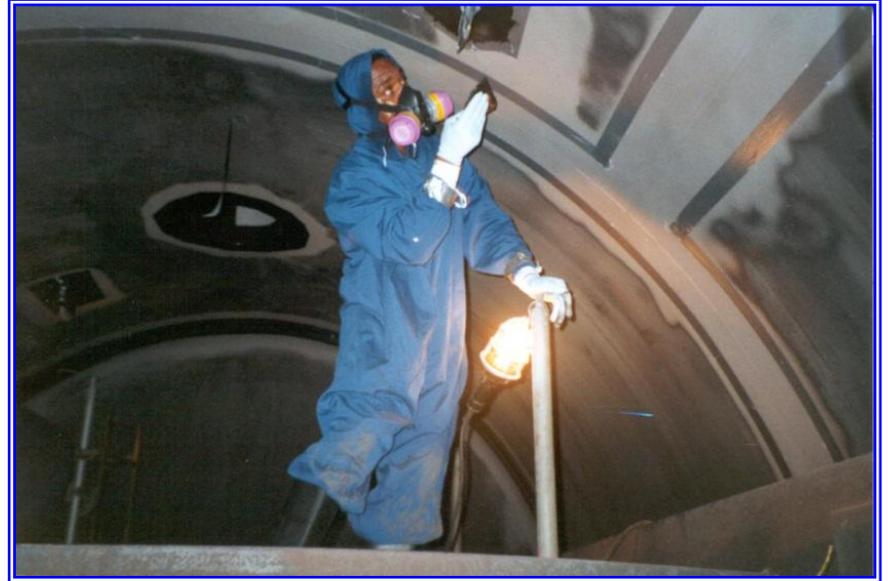
Protection of weld areas subject to stress corrosion cracking at elevated temperatures due to the presence of H<sub>2</sub>S. Weld areas only protected using high temperature Hybrid Epoxy Novolac lining system with operating temperature in excess of 150C

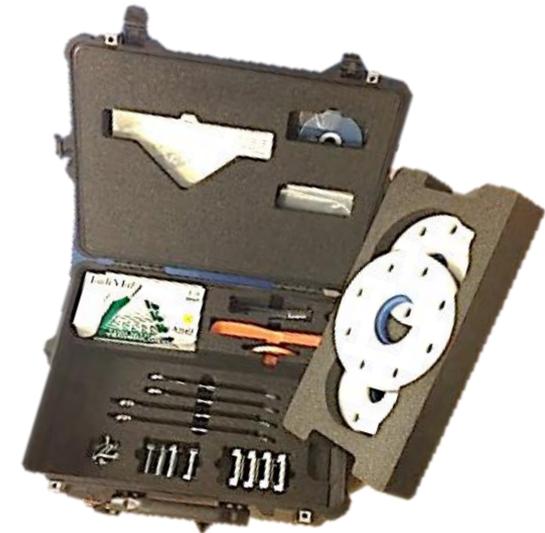
Flange Face Repair Kit

# Flange Face Repair and Protection

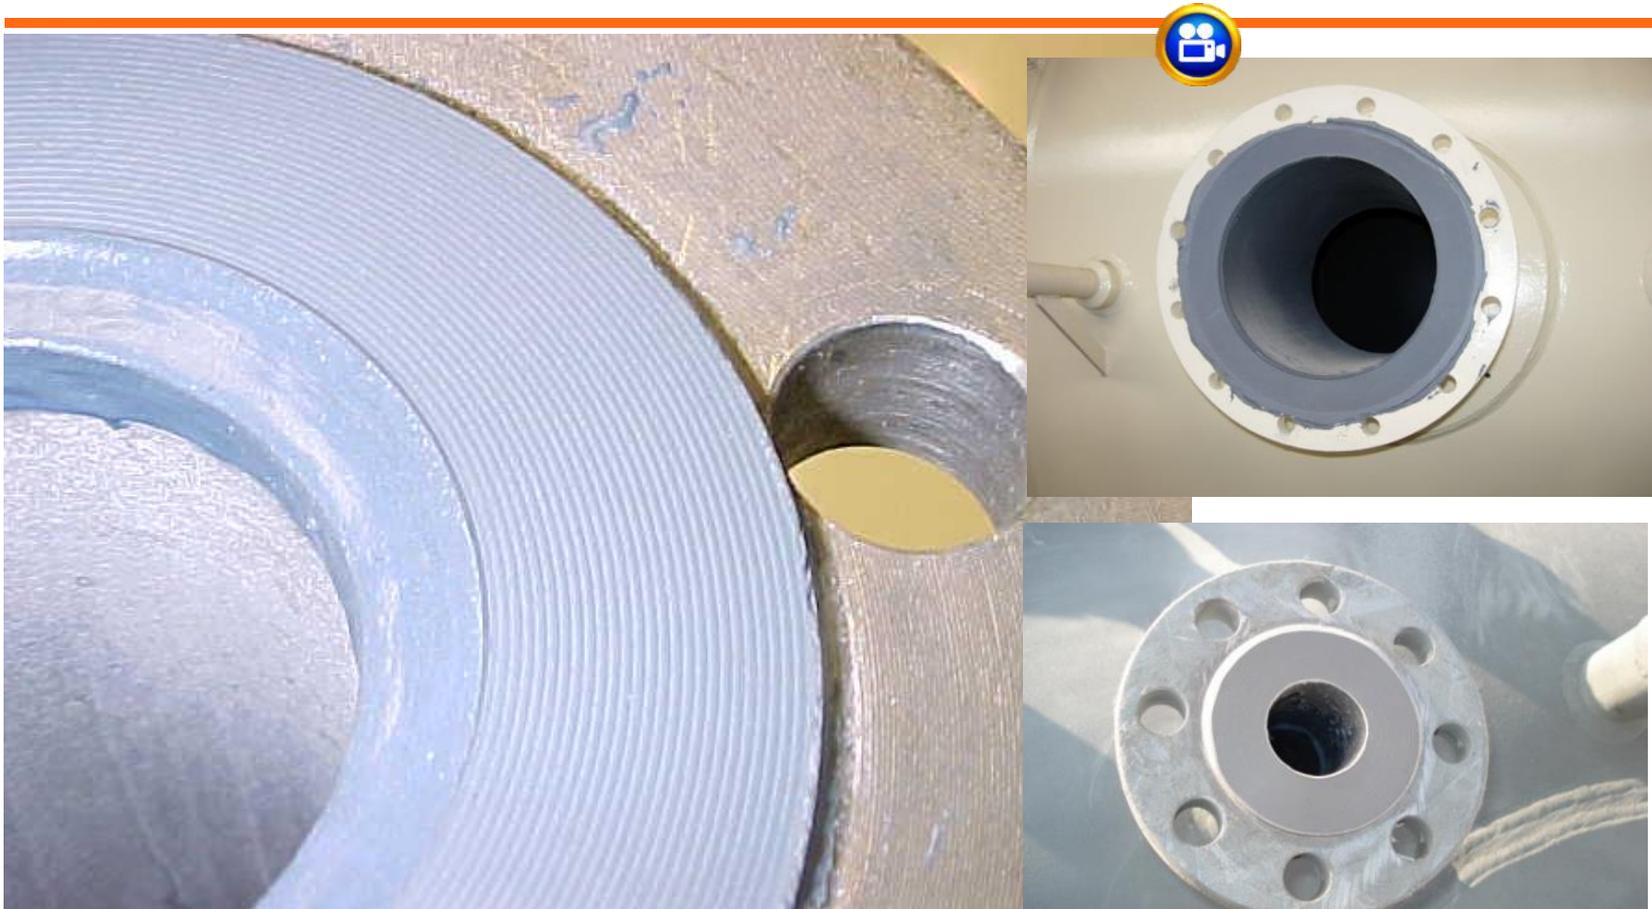
Flange faces formed using Belzona materials to prevent corrosion and leaks

**Suitable for : ANSI 150, 300, 600 and 900 Flanges.**

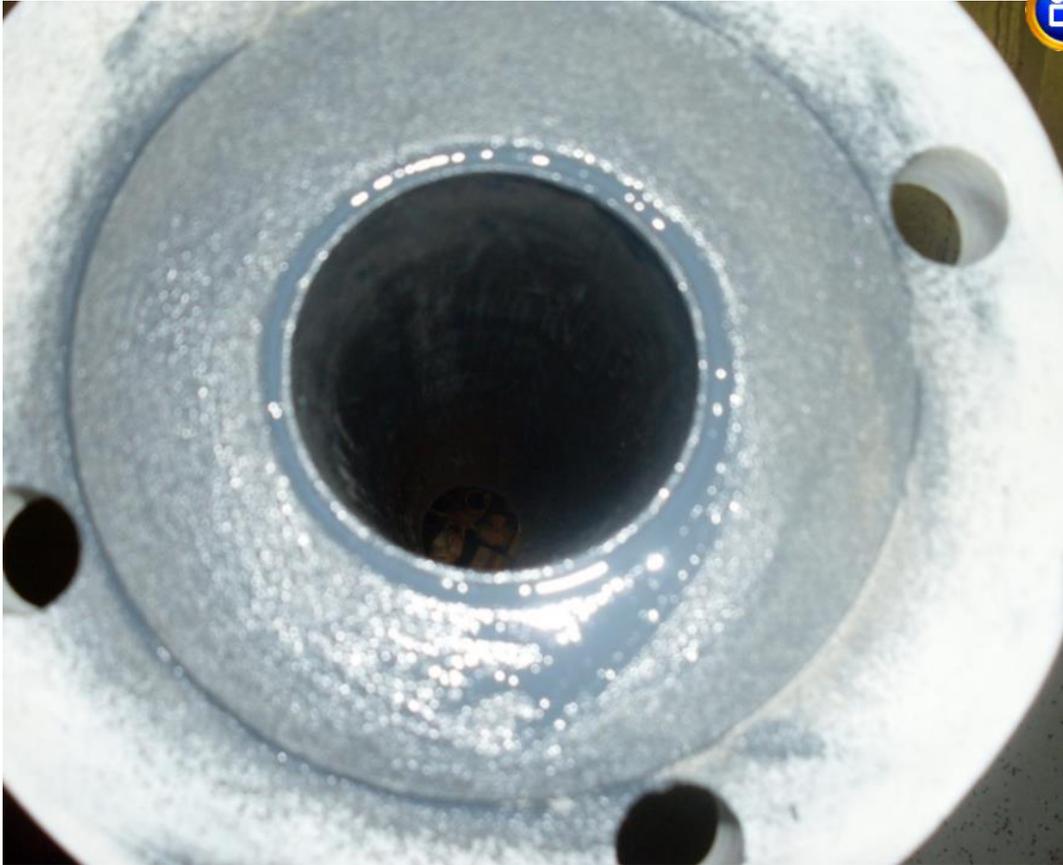
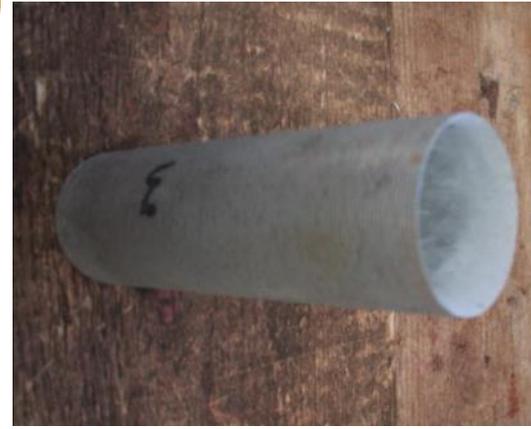
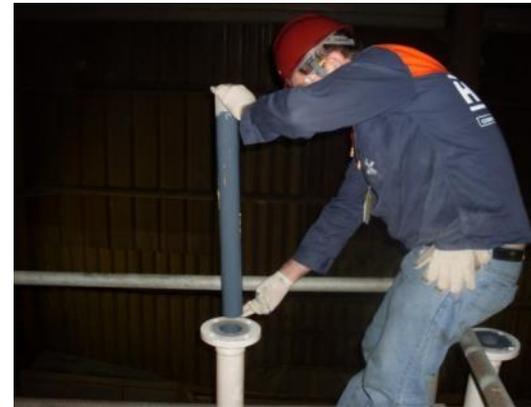
Belzona nozzle inserts bonded into small bore nozzles, protect against corrosion and erosion

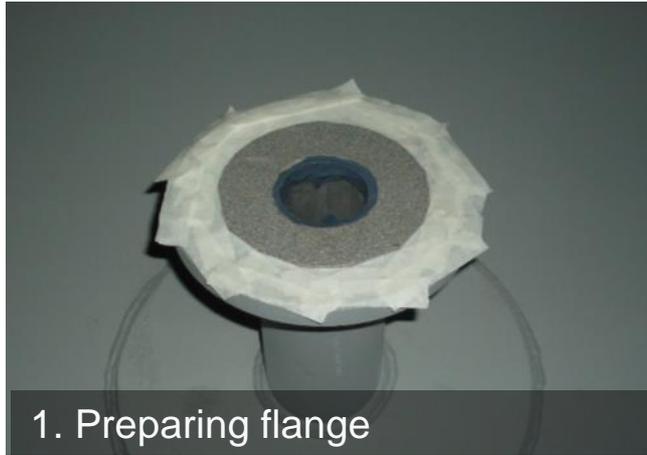
1. Preparing flange

Flange face forming and small bore nozzle protection, applied in 2009, inspected in 2013.

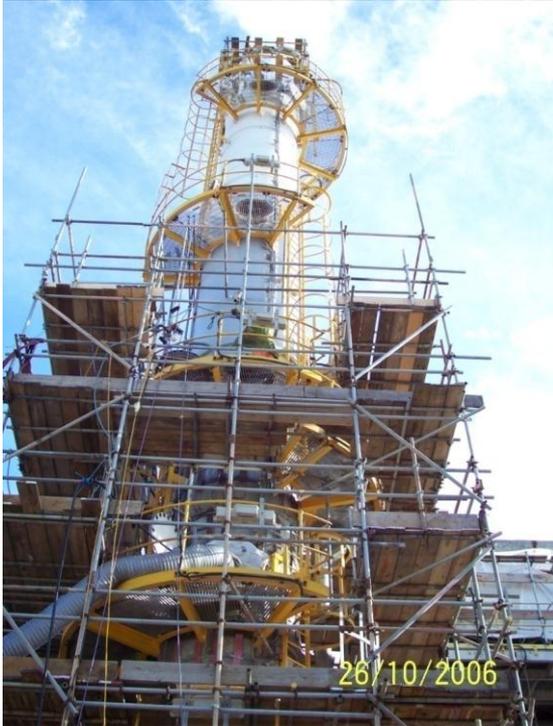
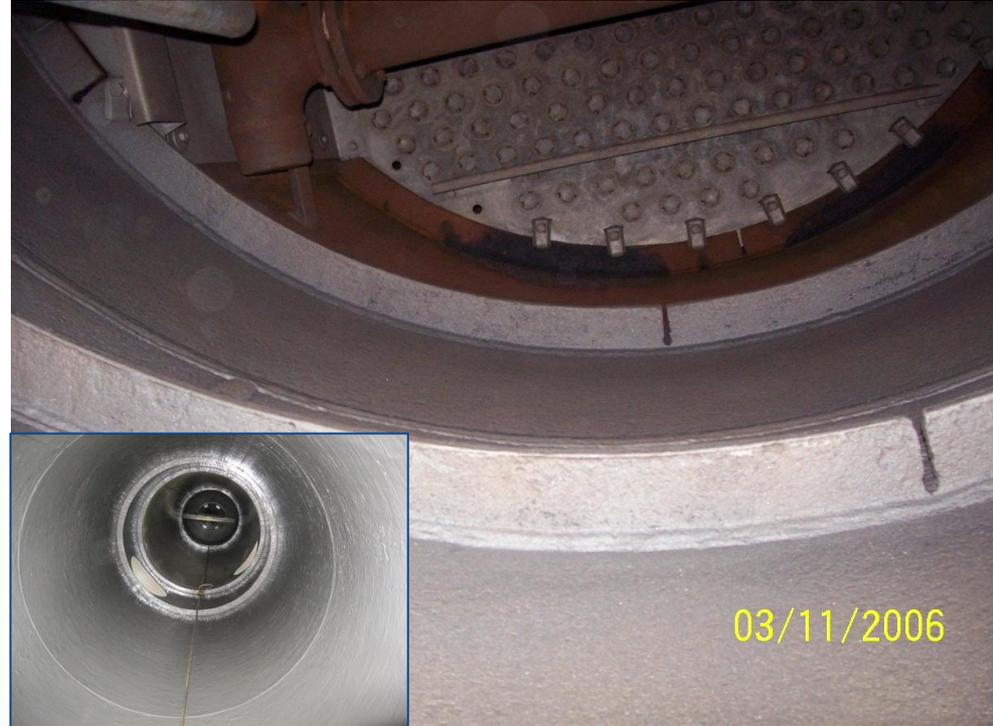
The acid washing process at elevated temperature led to severe pitting within the tower and significant loss of wall thickness adjacent to tray support rings. High Temperature repair compound used to restore wall thickness then acid resistant lining applied to resist operating conditions at 95C - Inspected in Year 2011 and in good condition.

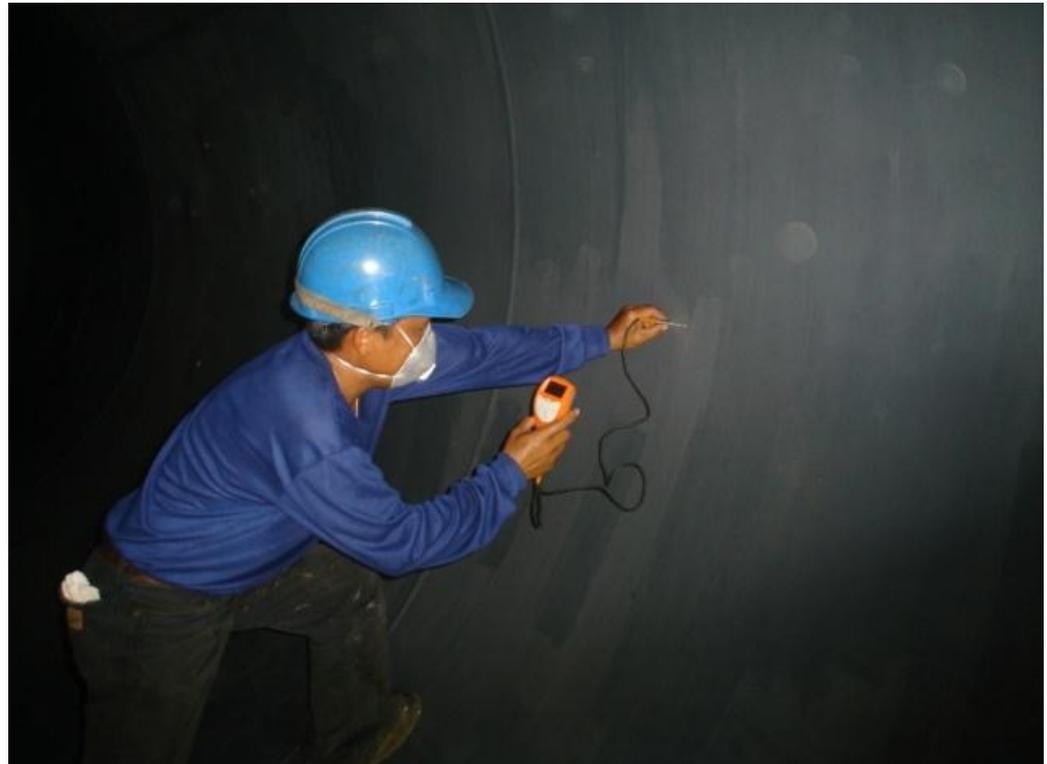
Chemical Process Tank

Severe corrosion due to chemical attack to tank resulted in costly replacement

High Temperature Epoxy Novolac internal lining selected for its excellent chemical resistance

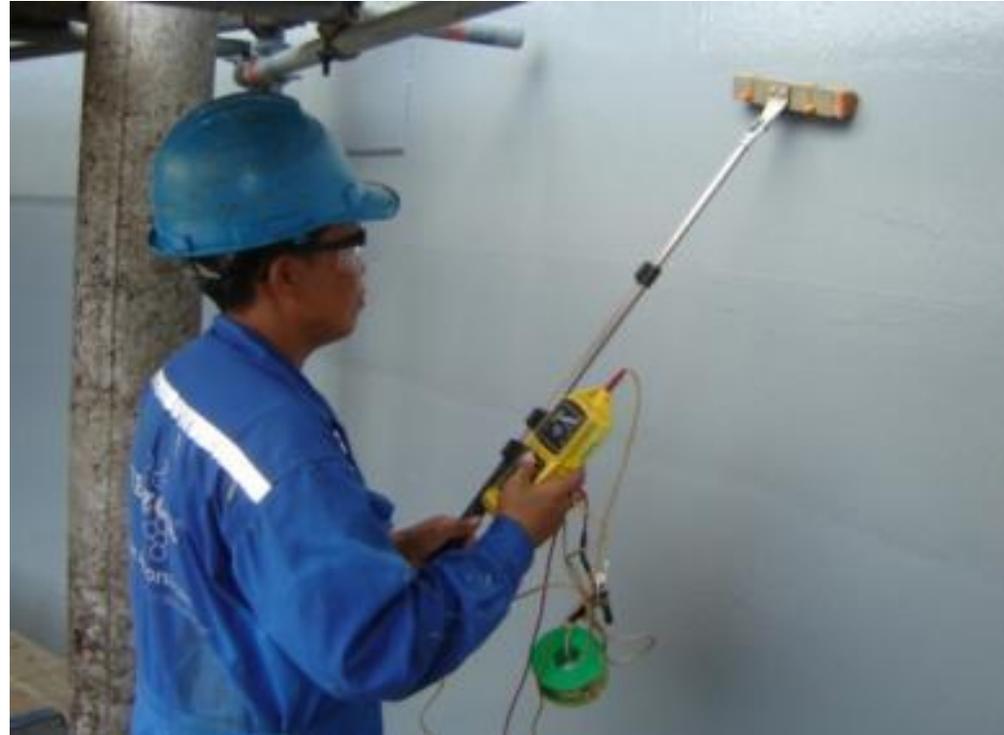
Large Steel tank used for the treatment of effluent

Corrosion pitting and loss of wall thickness due to previous coating failures

Repair compound used to repair pitting and bond plates to damaged areas then coating system applied

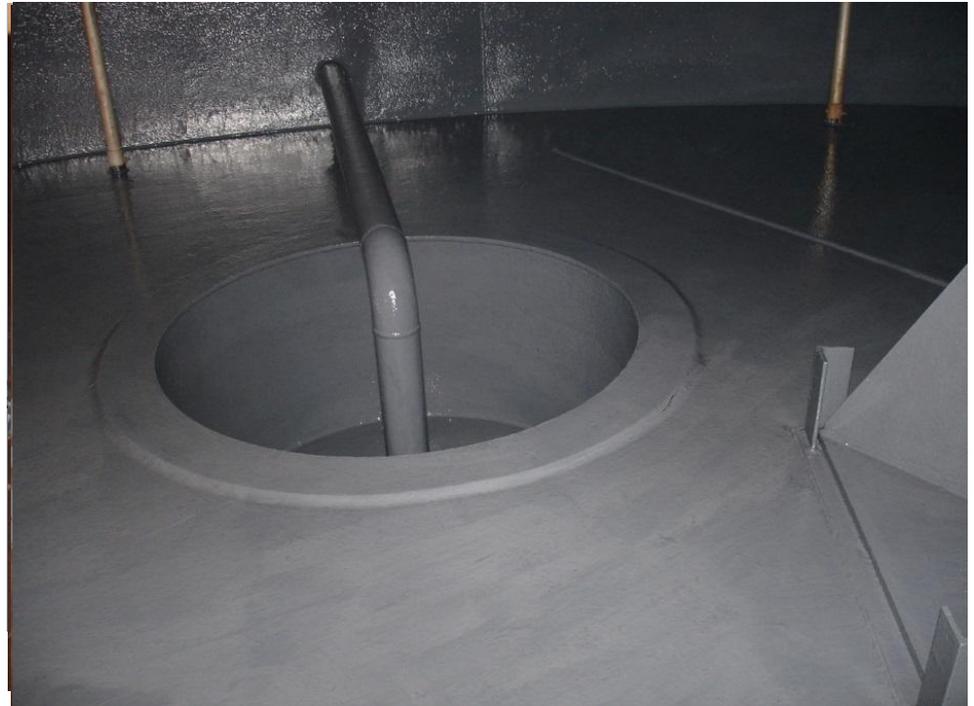
Hydrocarbon Storage Tank

Corrosion pitting and loss of thickness in the base of the tank due to previous coating failures

Repair compound used to fill pitting and bond plates to damages area of the tank then internal coating system Applied.
