Microbiological Induced Corrosion in Stainless Steel Piping: Mitigation Strategy

Taner Serter

Asset Integrity Division, SADARA Chemical Co.

April 26th, 2017

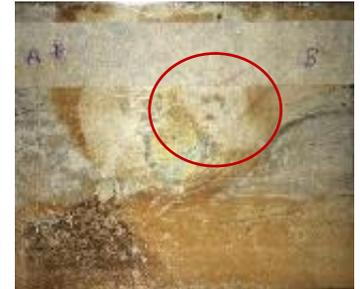
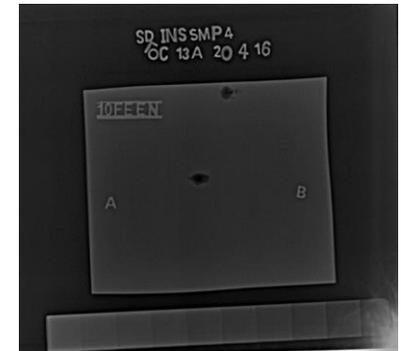
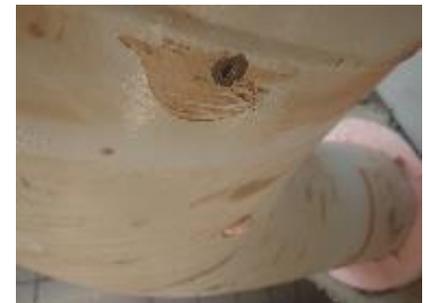
Sample Inspection Findings

- Defect Definition: Localized Pitting
- Defect Location: Pipe to Pipe/Pipe to Elbow/ HAZ and Weld
- Material Definition: A312 TP 304/304L- Sch10S
- Diameter Range: 4-30 inch(Higher the diameter more susceptible)

- Apply continuous monitoring and frequent inspection of SS piping systems with MIC risk
 - Include use of effective biocides in hydrotest water
 - Increase control of water quality
 - Ensure adherence to hydrotest procedures
 - Ensure adherence lay-up and preservation procedures
 - Avoidance of stagnant or no-flow process systems
 - Corrosion Management program to capture MIC monitoring and mitigation strategies
-
